**PRIVATE & CONFIDENTIAL  
BUILDING SURVEY REPORT  
PROPERTY STRANGFORD AREA  
St Joseph's Primary School  
Date of Inspection May 2023  
Weather: Clear  
Ref: 20230524**

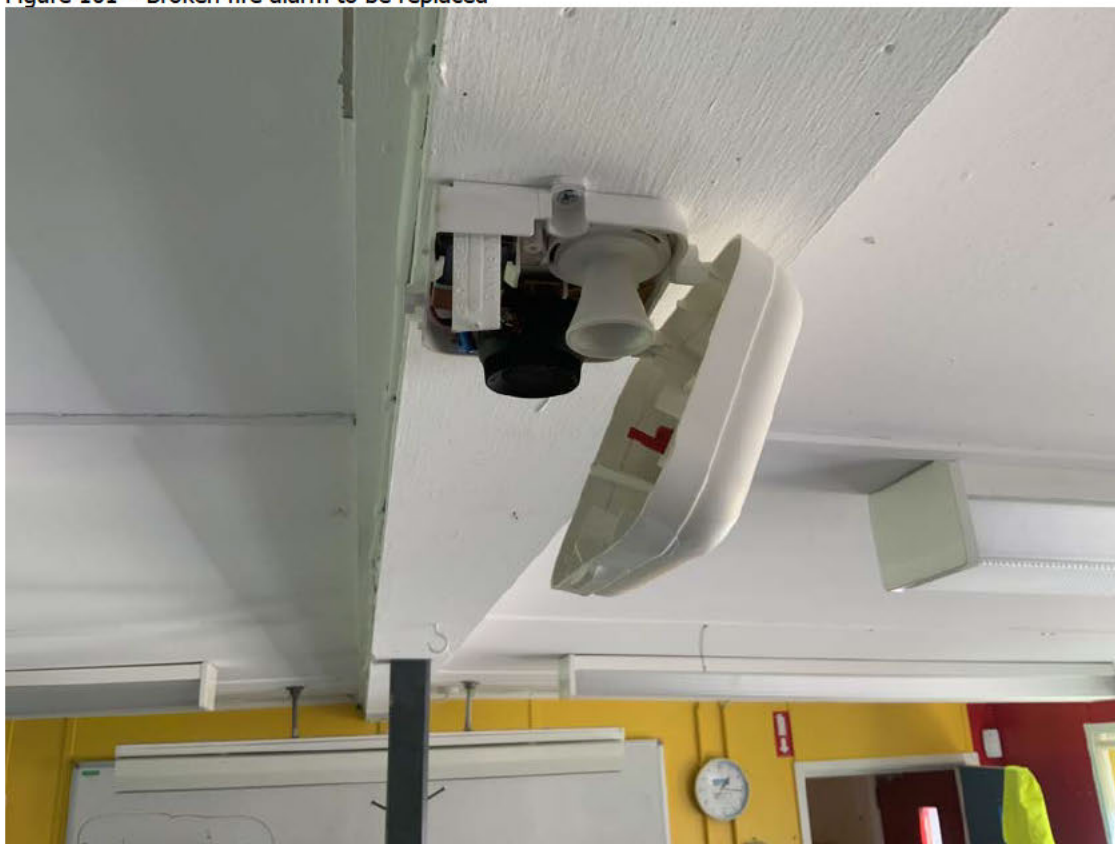
Figure 101 – Broken fire alarm to be replaced

1.05 Fire alarms need to be repaired or replaced. (see figure 101)

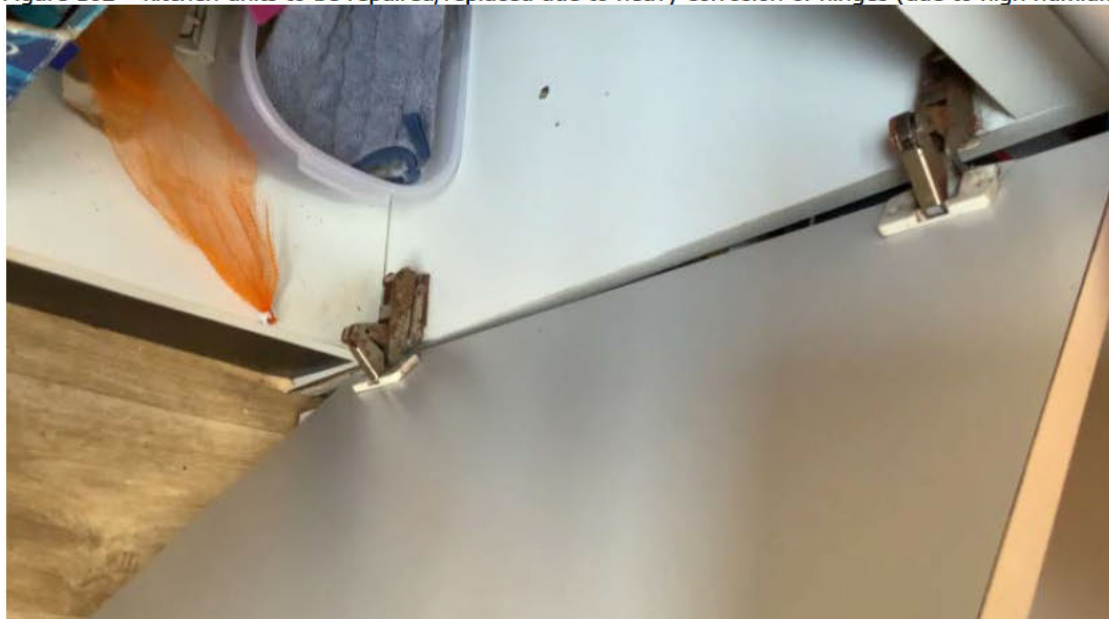
Figure 102 – kitchen units to be repaired/replaced due to heavy corrosion of hinges (due to high humidity)

The kitchen unit hinges are in poor condition and should be replaced.

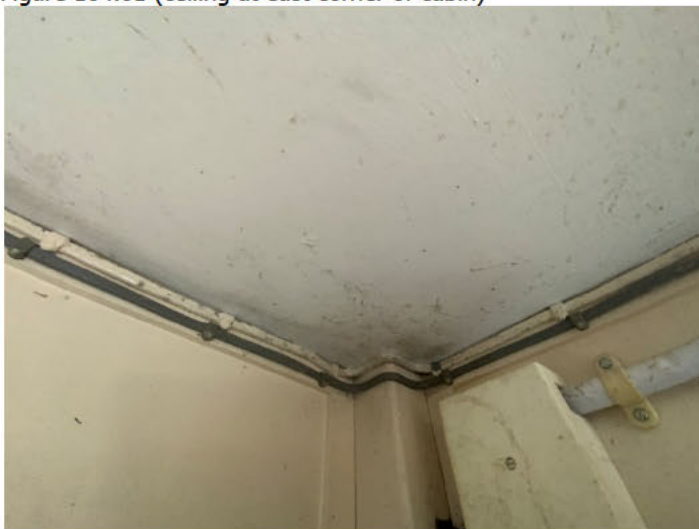
Figure 104.01 (ceiling at east corner of cabin)

Figure 104 – black mould on ceiling

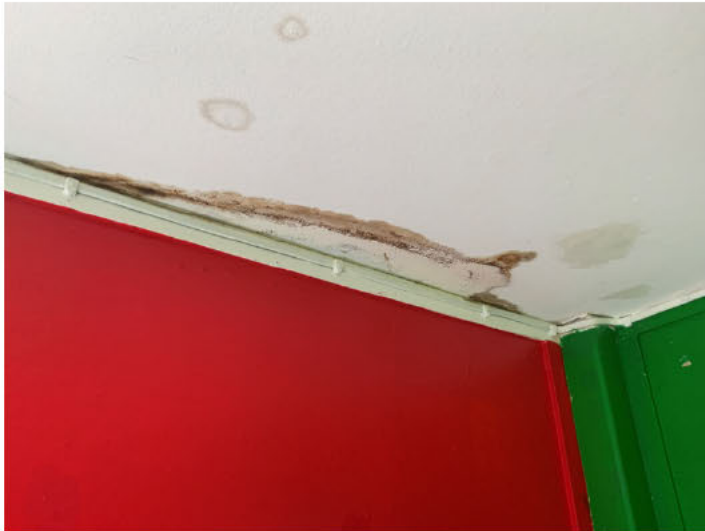
Figure 104.03 (ceiling at south corner of cabin – damp from roof outlet/internal downpipes)

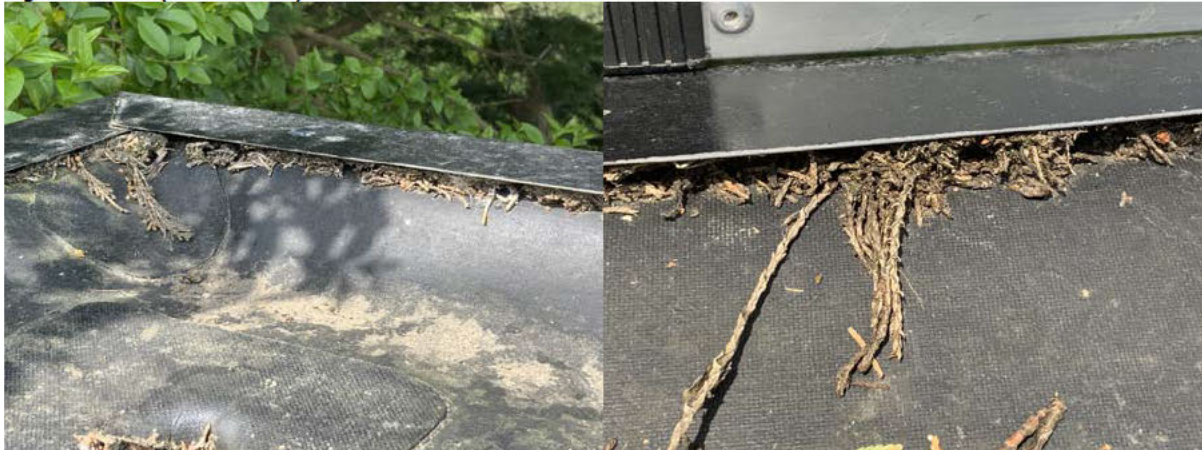
Figure 105.01 (West corner)

Figure 105 – Visible gaps in corners of roof covering

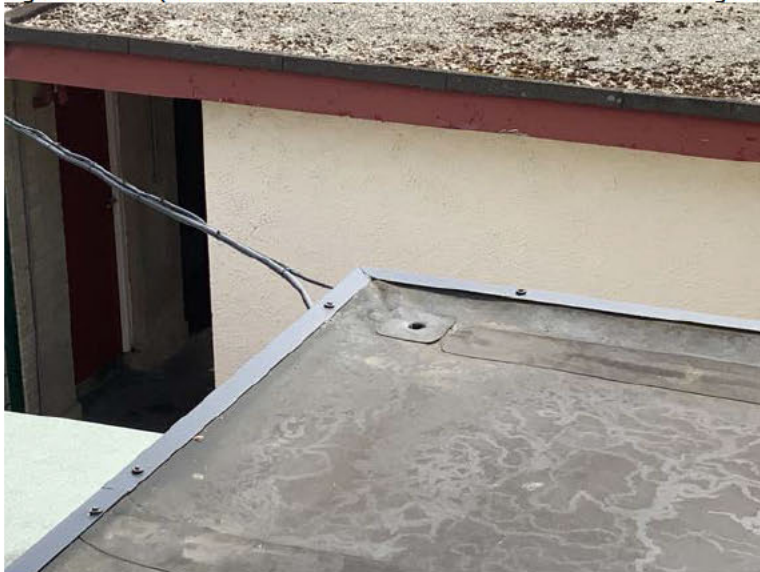
Figure 105.03 (East corner – location of overhead cables connecting from school)

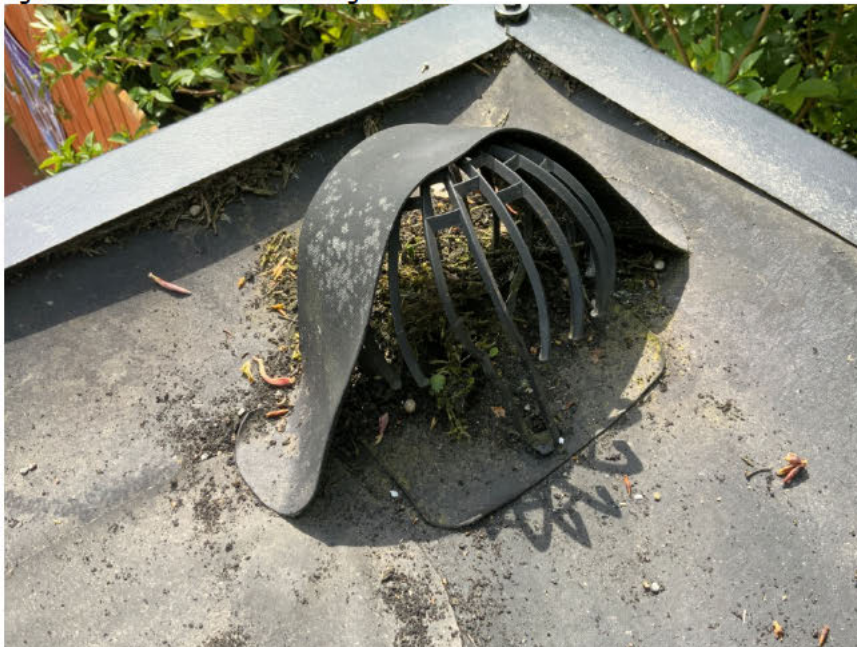
6.02 There are signs of water damage on the ceiling underneath south corner as a result of insufficient maintenance and/or possible faults in membrane (see figure 106).

Figure 106 – Blocked roof drainage outlets

6.03 North and east rainwater outlets have no leafguards and require maintenance.

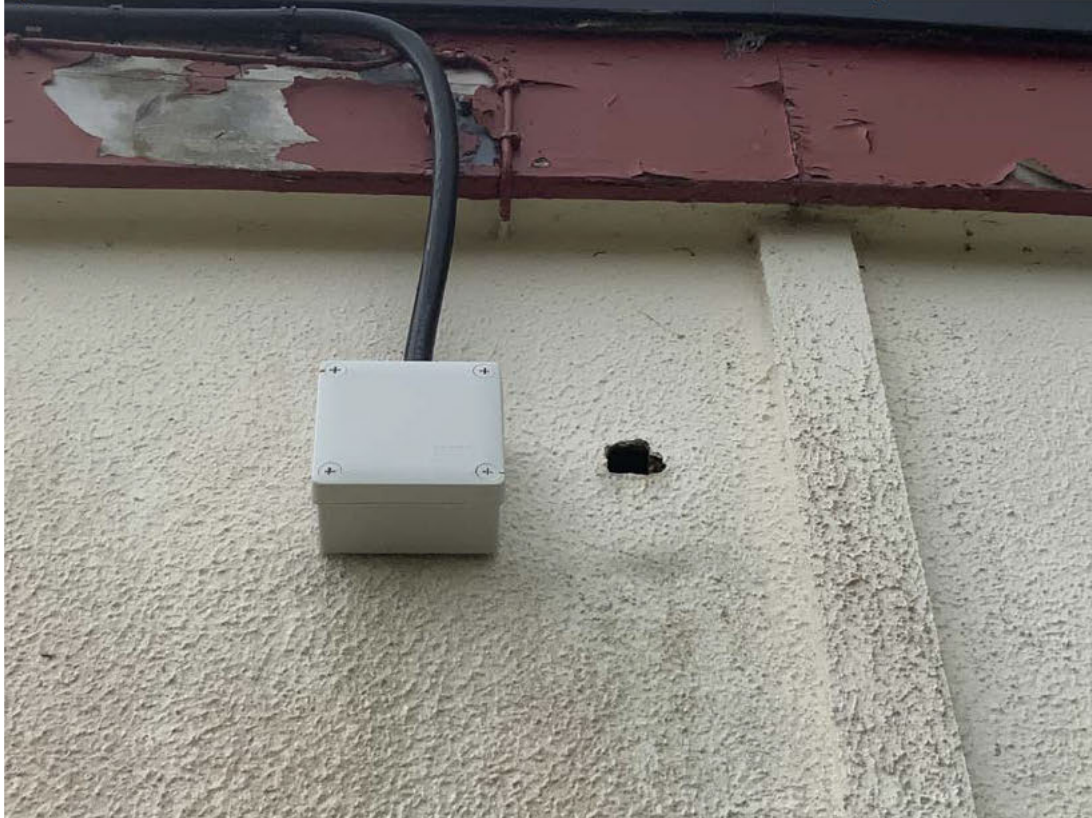
Figure 107 – Hole in wall on northeast elevation were birds have been seen nesting

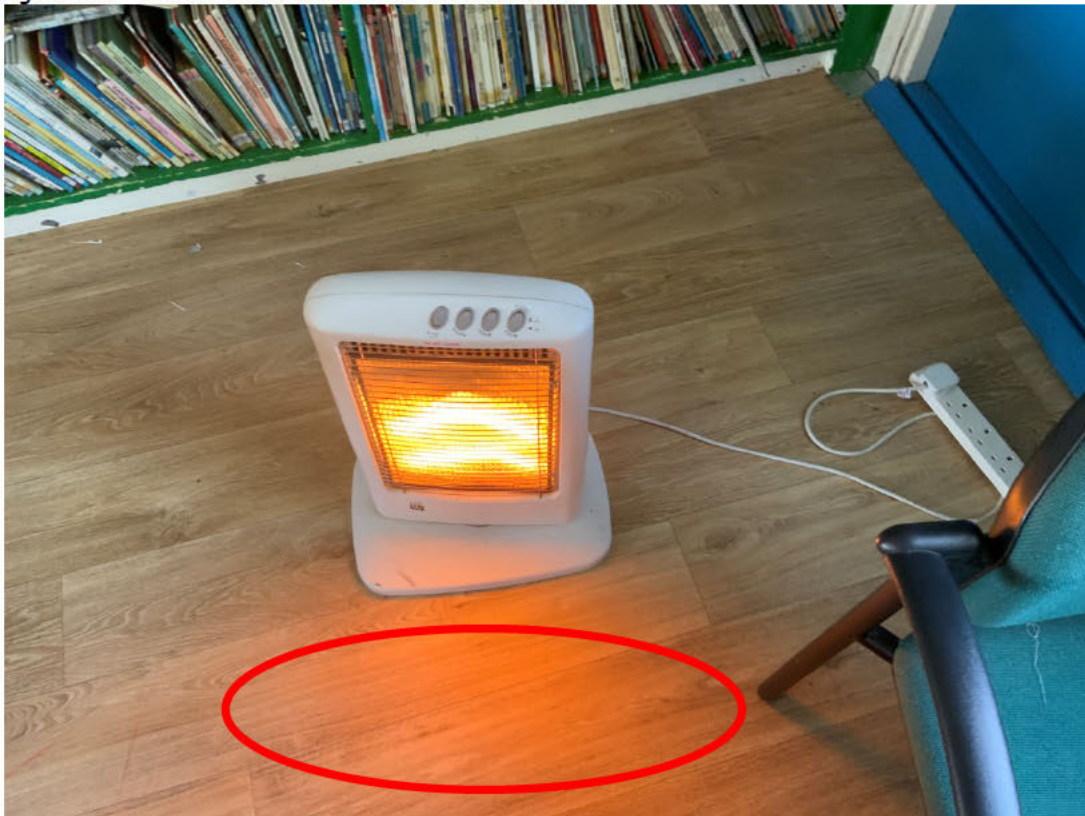
Figure 108 – Area of movement in floor in west corner

12.03 The floor generally slopes towards the west corner. There are some movement in this area that indicates water damage. (see figure 108)

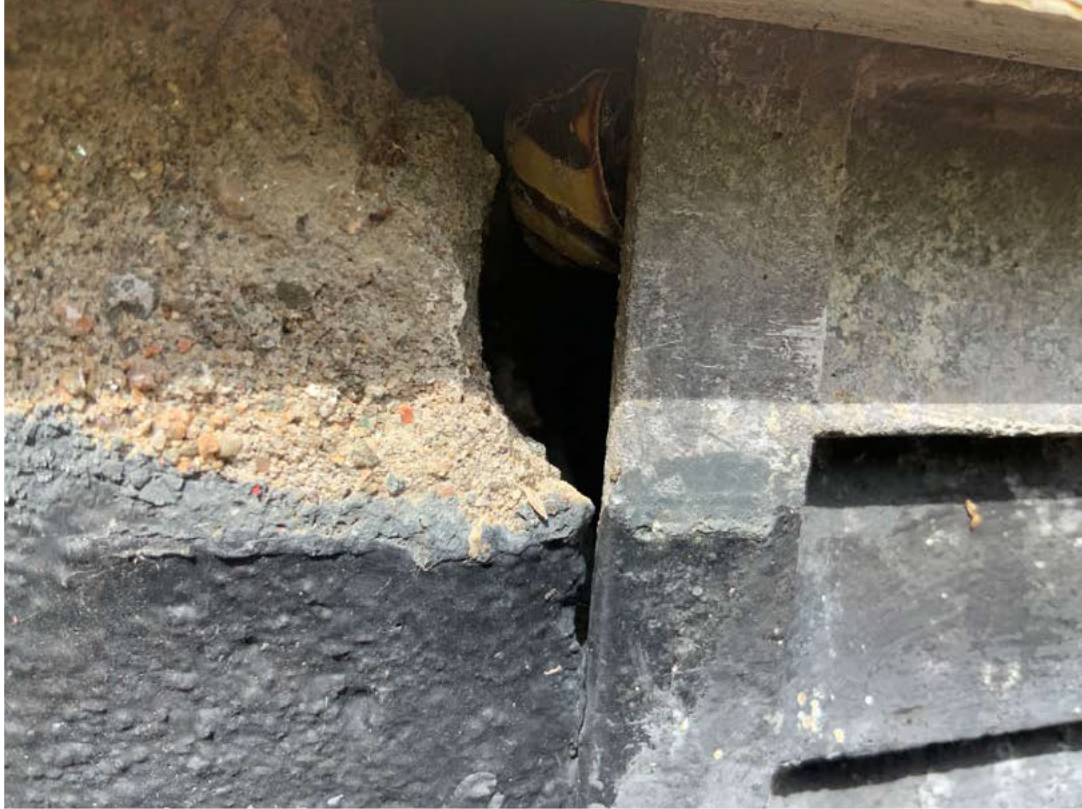
7.09 There are vents in the substructure where the majority of cracks can be located which should be repaired. One vent on the south east elevation appears to have large holes on the top corners where pests such as mice and rats may be able to access the floor void below building (see figure 109).  
Staff advised surveyors of previous rat infestation

Figure 109 – Holes next to vent (southeast elevation next to gully) where pests may have access to floor

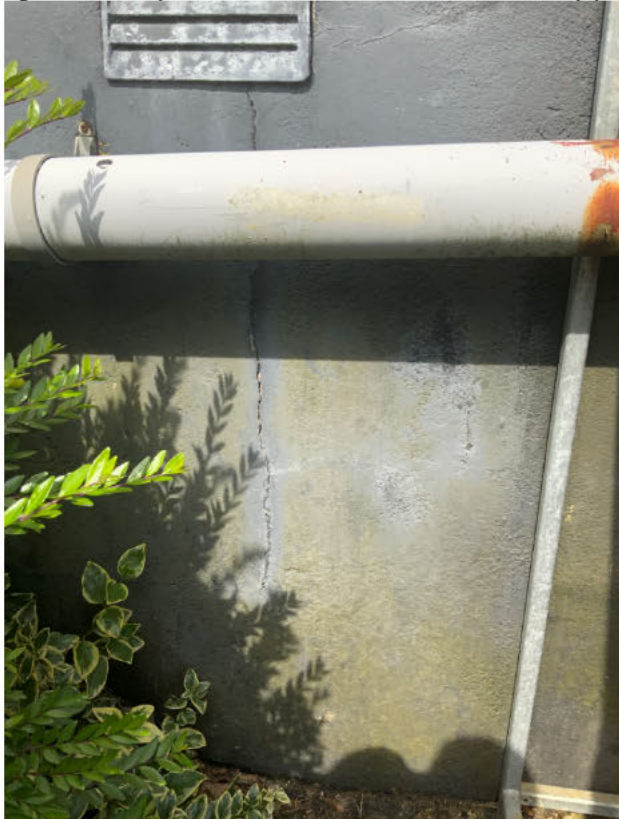
Figure 110.01 (southeast elevation behind loose downpipe)

7.04 Several structural defects were observed as cracks and holes in the lower wall. This is likely due to a combination of water damage and movement due to the age of the building (see figure 110).

Figure 110 – cracks in substructure portion of wall

1.09 Holes and cracks in substructure and rendered facades indicate movement in structure and require repairs or replacement.

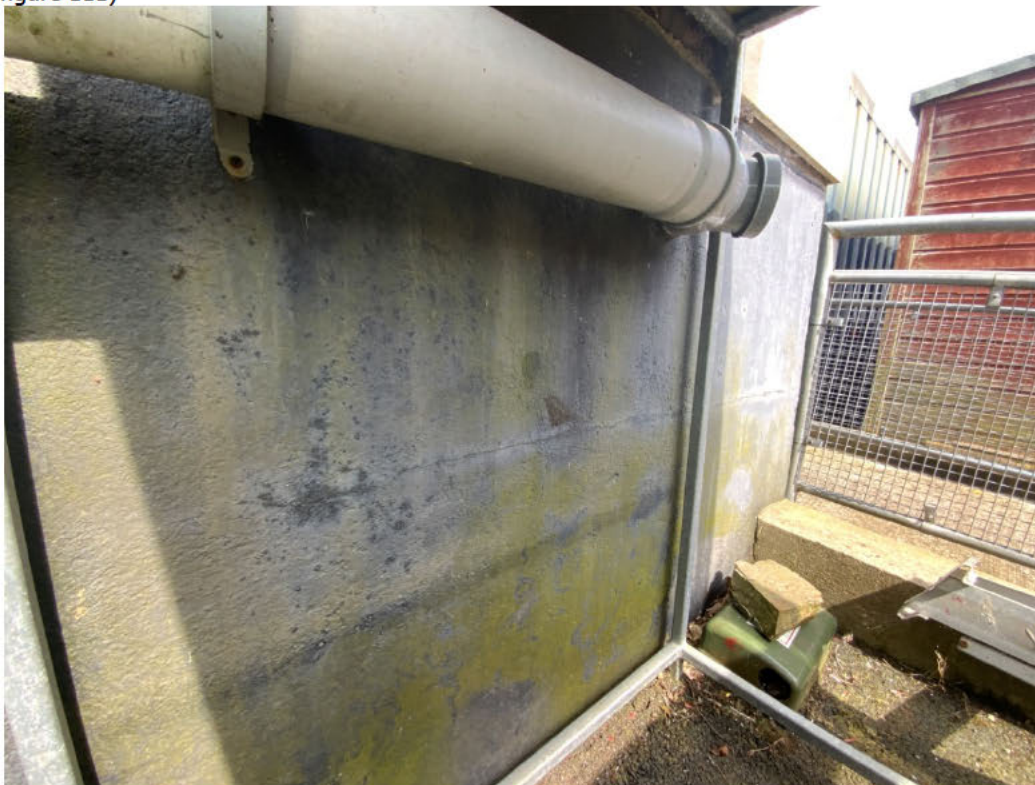
Figure 110.02 (southeast underneath stairs to main entrance – also shows broken pipe brackets as described in figure 111)

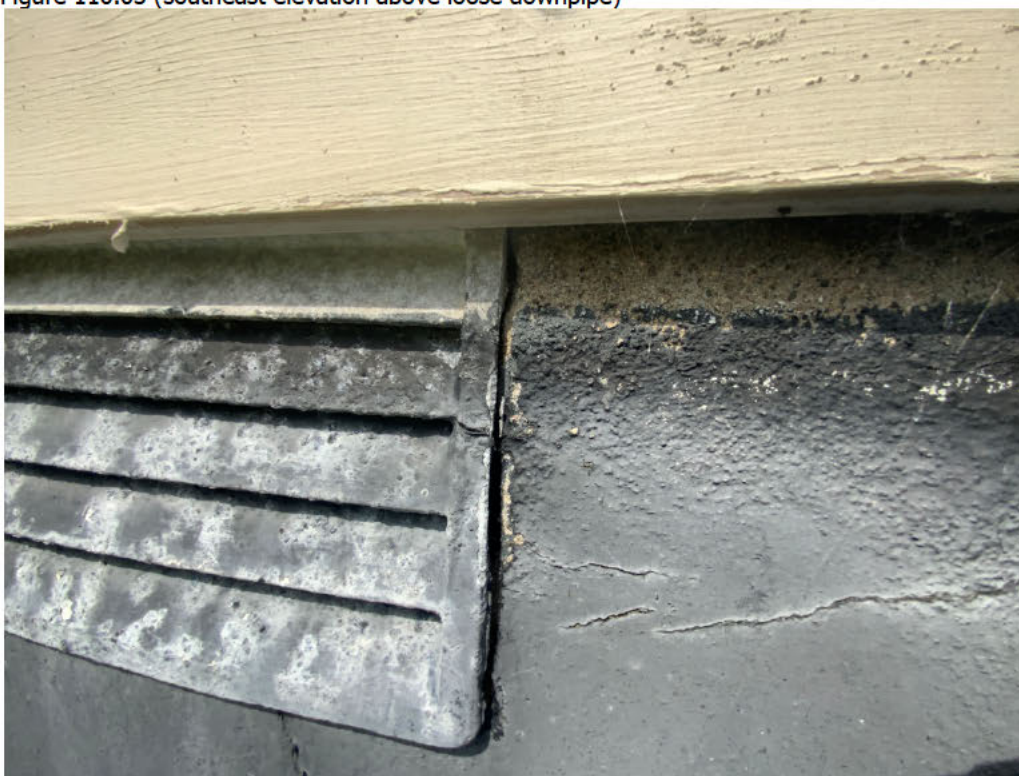
Figure 110.03 (southeast elevation above loose downpipe)

Figure 110 – cracks in substructure portion of wall

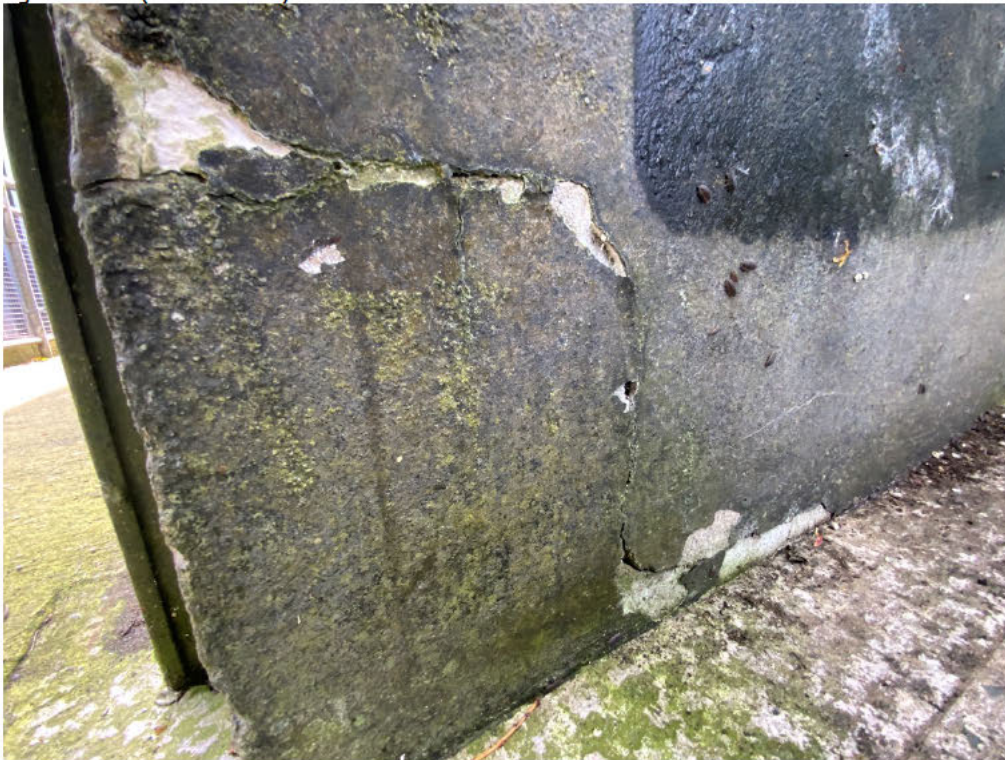
Figure 110.5 (north corner)

Figure 110 – cracks in substructure portion of wall

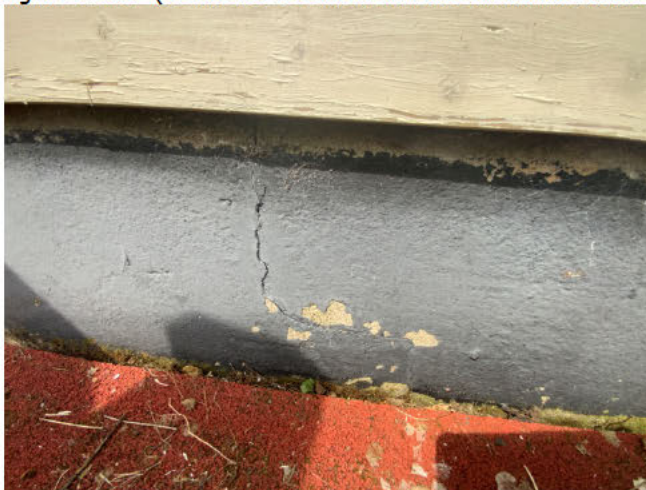
Figure 110.07 (southeast elevation underneath middle window)

Figure 110 – cracks in substructure portion of wall

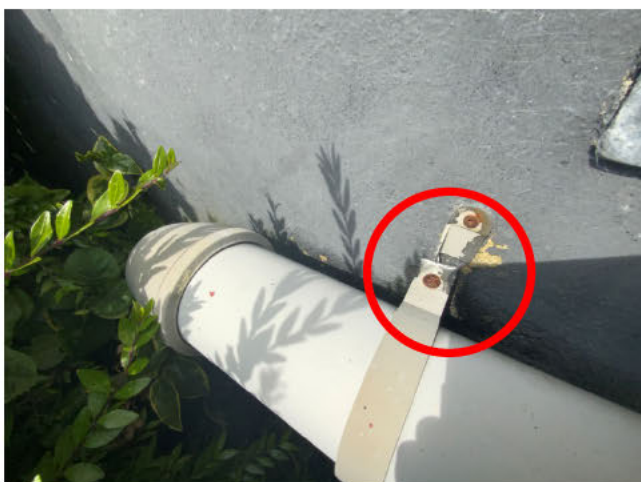
7.07 One of the externally mounted waste water pipes, located under the main entrance steps, has come off the supports that attach it to the building, and needs to be repaired or replaced immediately (see figure 111).

Figure 111 – loose pipe on southeast elevation

Figure 111.01 (broken support next to vent)

1.12 Drainage brackets for external waste pipe need replaced.

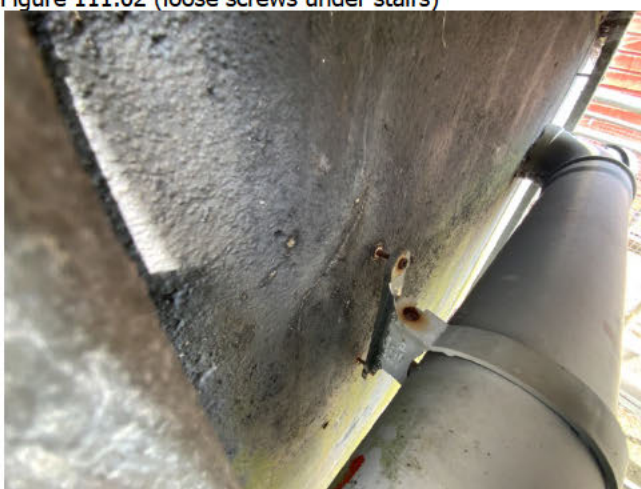
Figure 111.02 (loose screws under stairs)

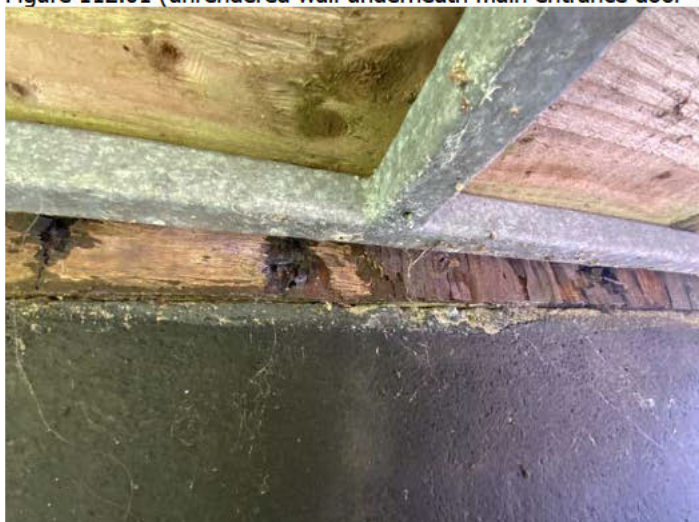
7.01 The cabin external walls comprise of stucco rendered wooden panels with timber batten at joints. In places the render finish has deteriorated and left timber exposed. Where this is seen there is significant rot visible in the wooden structure of the walls. If the building is to continue operation, you should replace all the wooden panels as damp and rot will likely be present in many other areas not immediately visible (see figure 112). The bottom of this section of wall has been lined with wooden skirting, which appears to have been recently replaced around the southern corner of the building.

Figure 112 – Peeling render and rotting wood on external walls

Figure 112.01 (unrendered wall underneath main entrance door – panel is rotten)

1.11 External cladding to be repaired and sufficiently maintained.

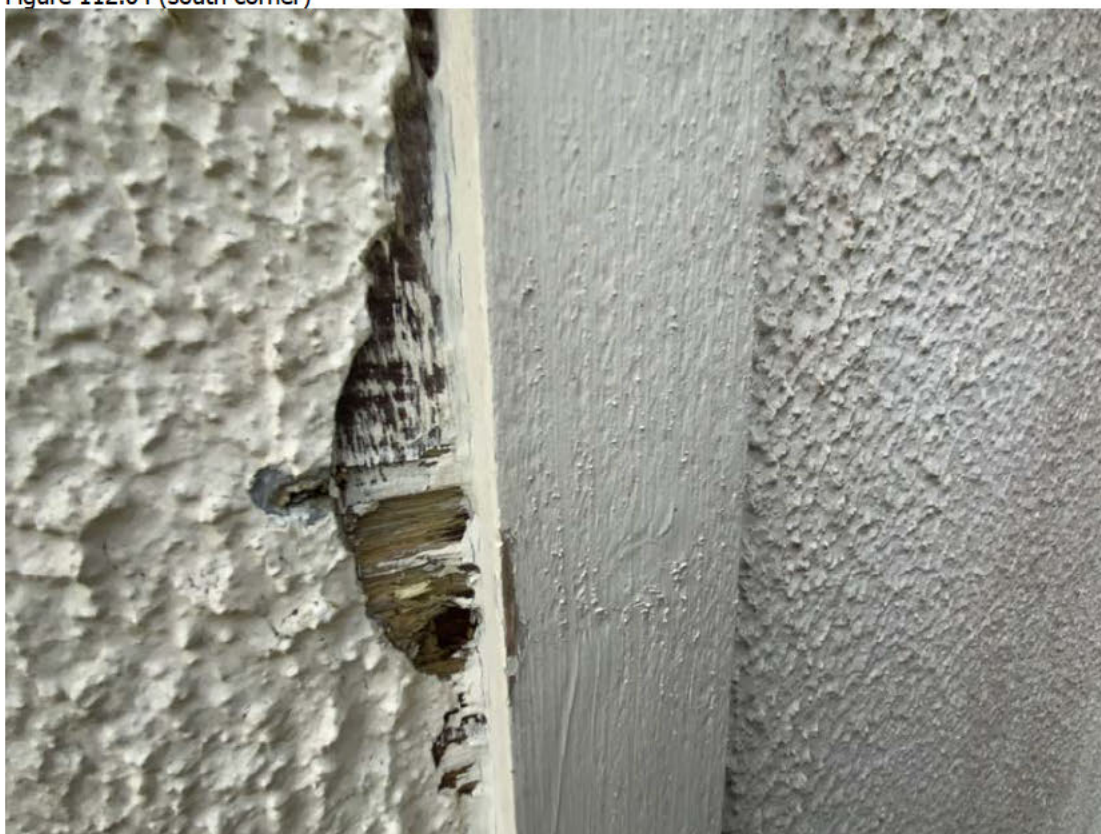
Figure 112 – Peeling render and rotting wood on external walls  
Figure 112.04 (south corner)

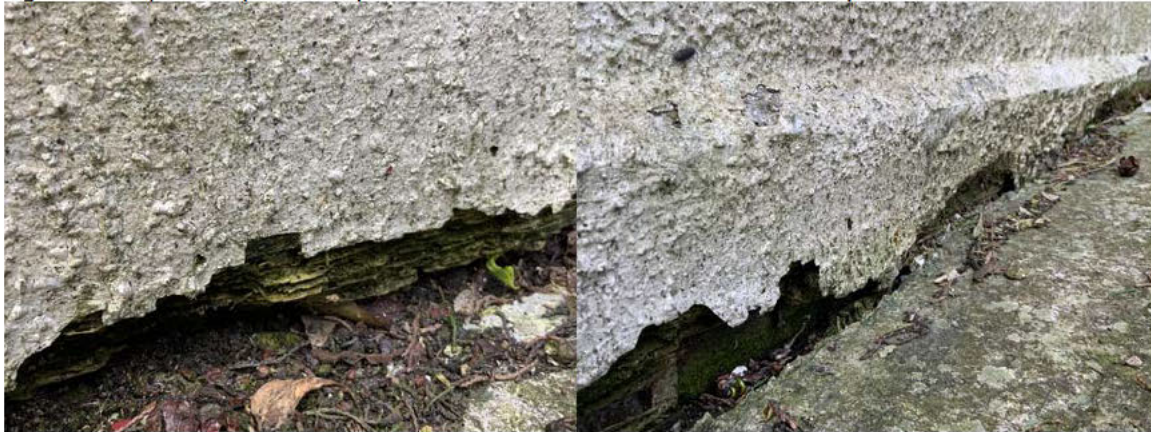
Figure 112 – Peeling render and rotting wood on external walls

Figure 112.06/112.07 (extensive peel and rot on bottom of northwest elevation)

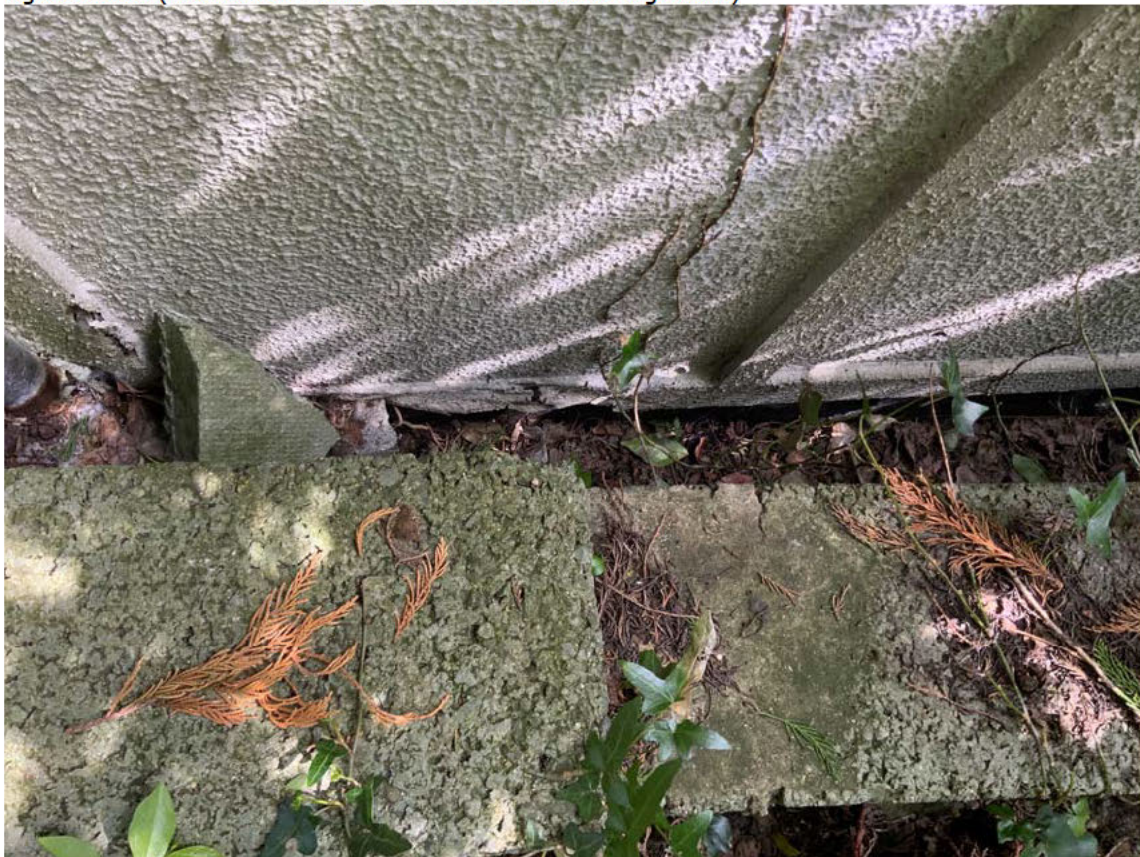
Figure 112.08 (west corner – access limited due to dense vegetation)

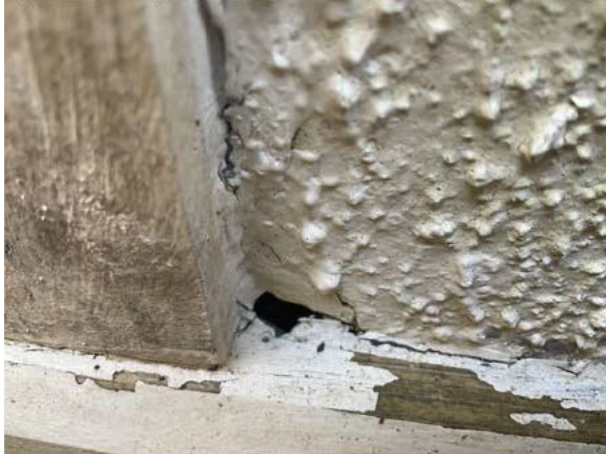
Figure 112.09 (southeast elevation beside gully)

Figure 112 – Peeling render and rotting wood on external walls

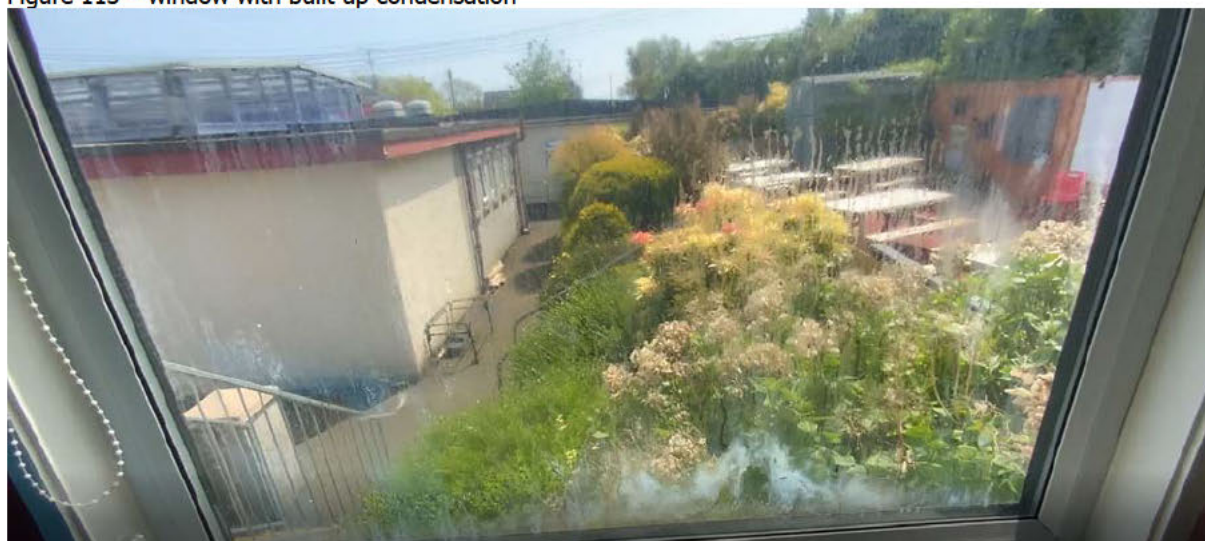
8.03 The window shown in figure 113 appears to have condensation built up behind the glazing, and will need to be replaced with new glazing.

Figure 113 – window with built up condensation

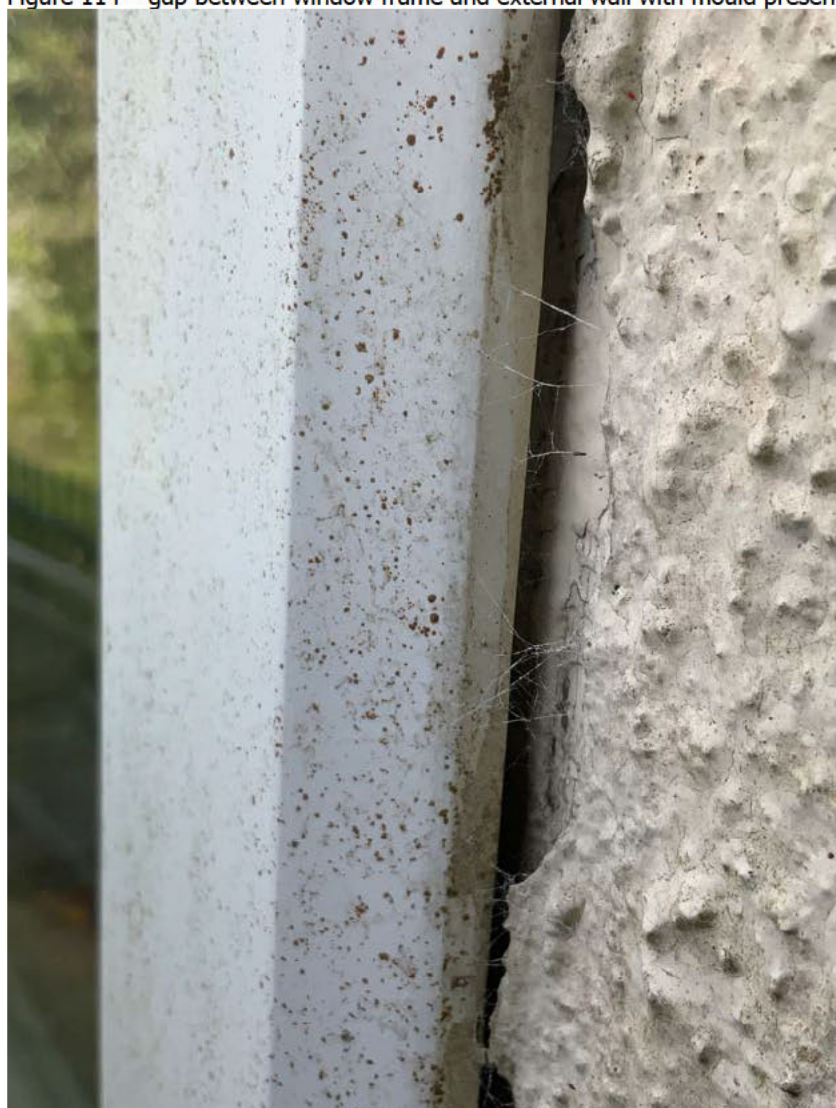
8.02 The majority of the windows are in reasonable condition for their age. There is minor damage and distortion of the sills and windows themselves that requires no repairs, however there are two windows highlighted that require repairs (see figures 113 + 114).

Figure 114 – gap between window frame and external wall with mould present

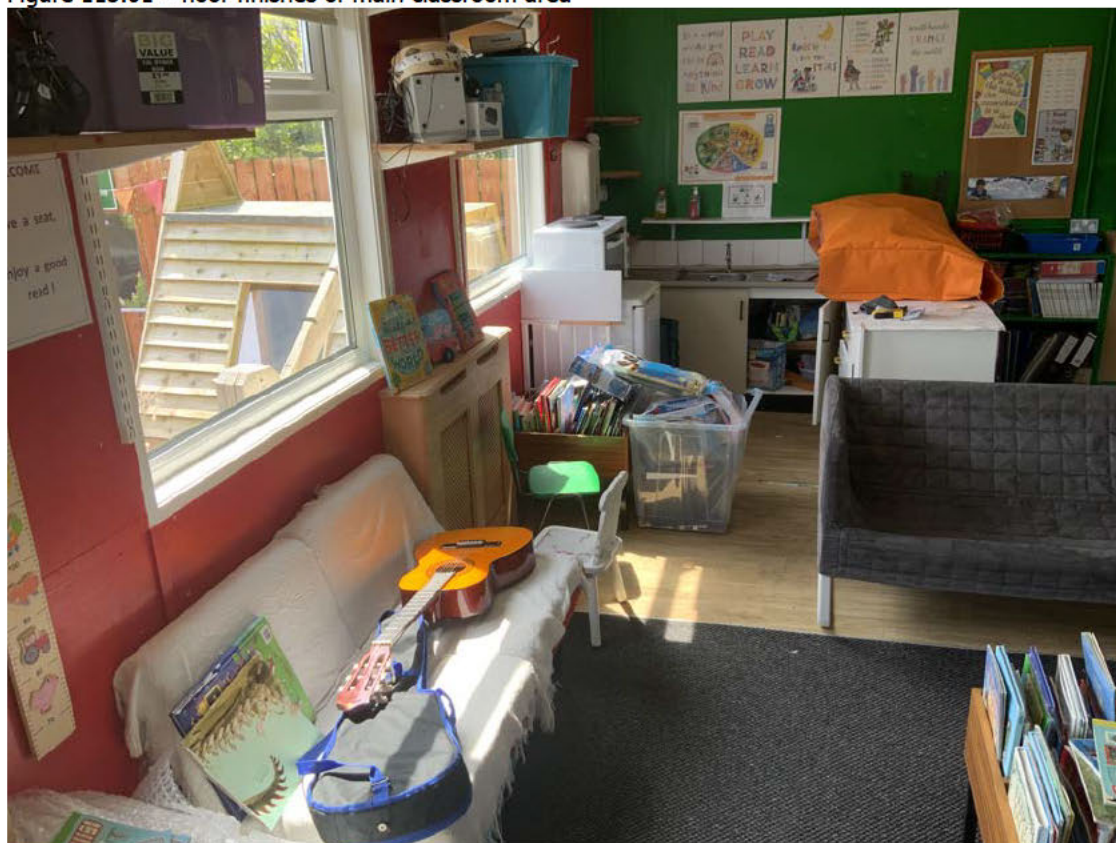
12.02 The floor is generally not in good condition. Most readings show dampness in many places, and in the main classroom area some of the upper lamination is peeling off. These laminated surfaces may need to be replaced.

Figure 115.01 – floor finishes of main classroom area

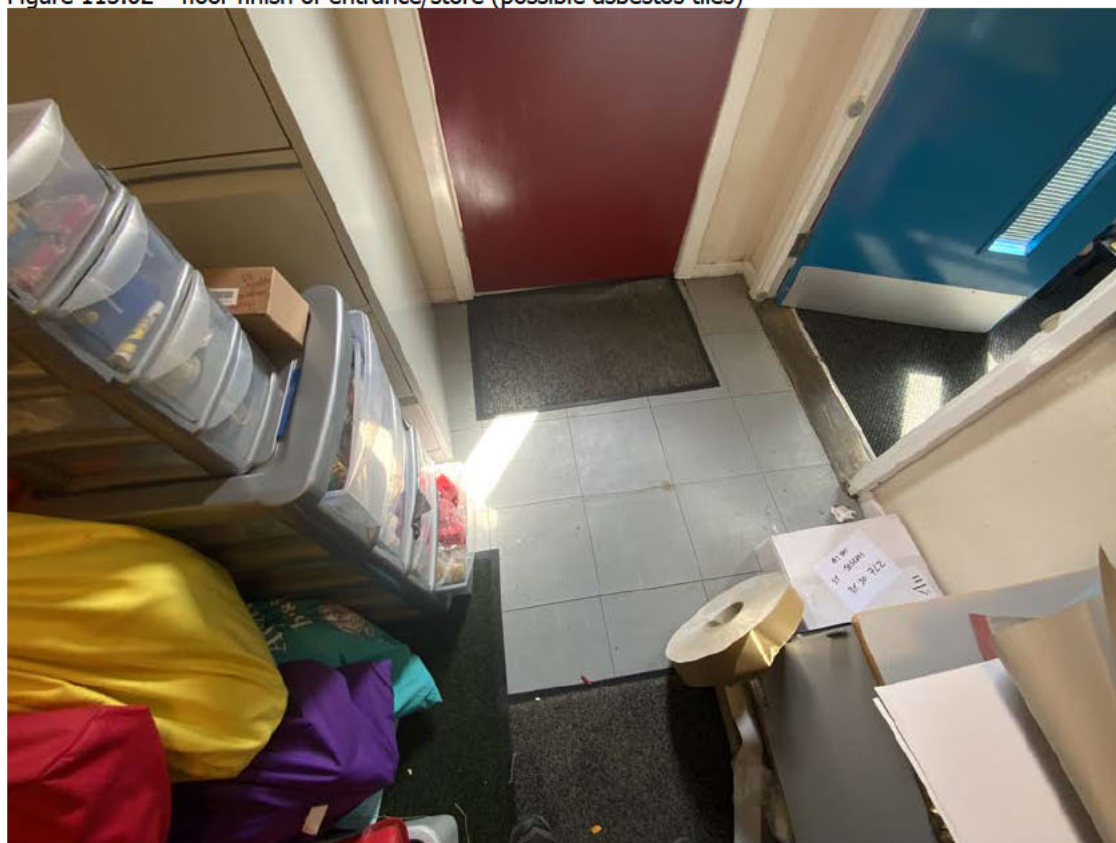
Figure 115.02 – floor finish of entrance/store (possible asbestos tiles)

23.03 While it is unknown if asbestos is present, the health risk is considered very low under normal conditions and usage. No action is required unless the components are damaged, worked on, altered, replaced or used in a different way. If this happens an asbestos specialist should be called in. The costs involved may be higher than similar work carried out on materials that do not contain asbestos, and it may be more cost effective to replace the cabin entirely if this is the case

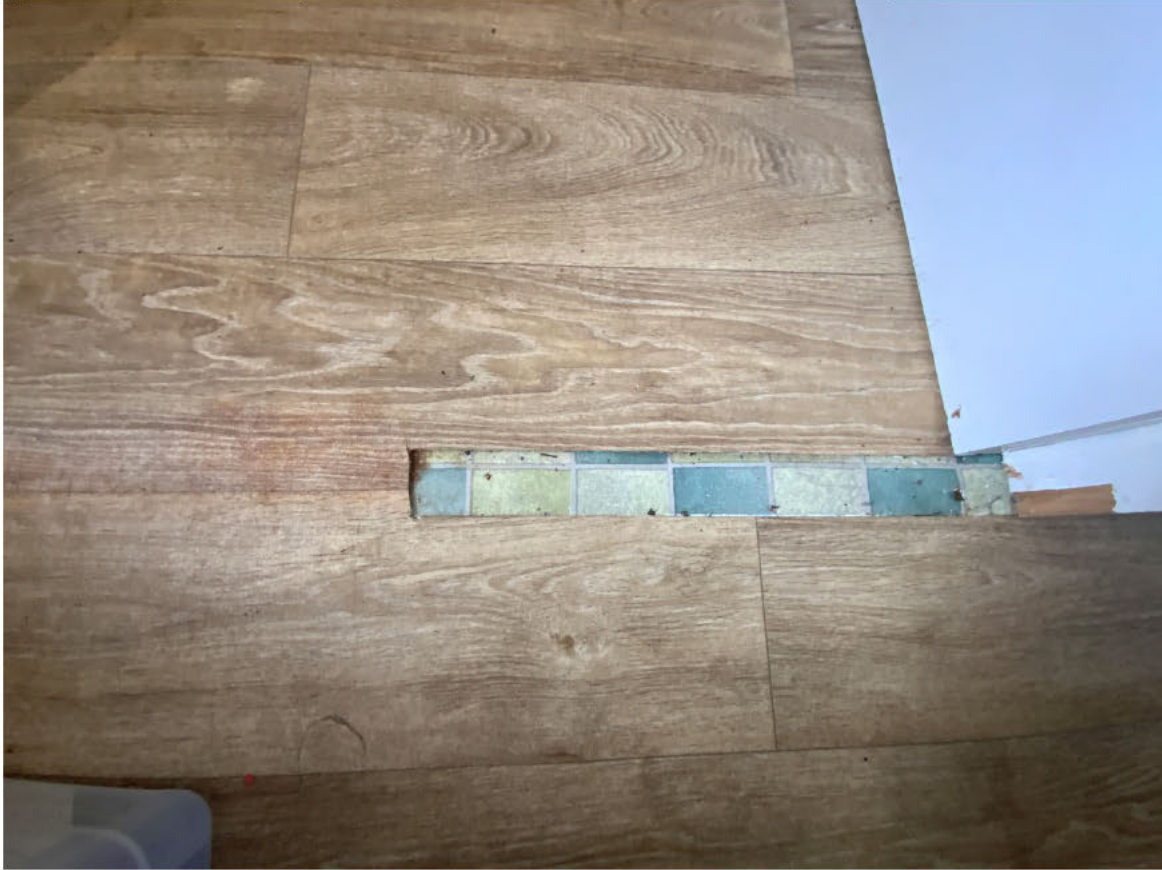
Figure 115.03 – previous vinyl flooring covered with newer wood effect vinyl flooring

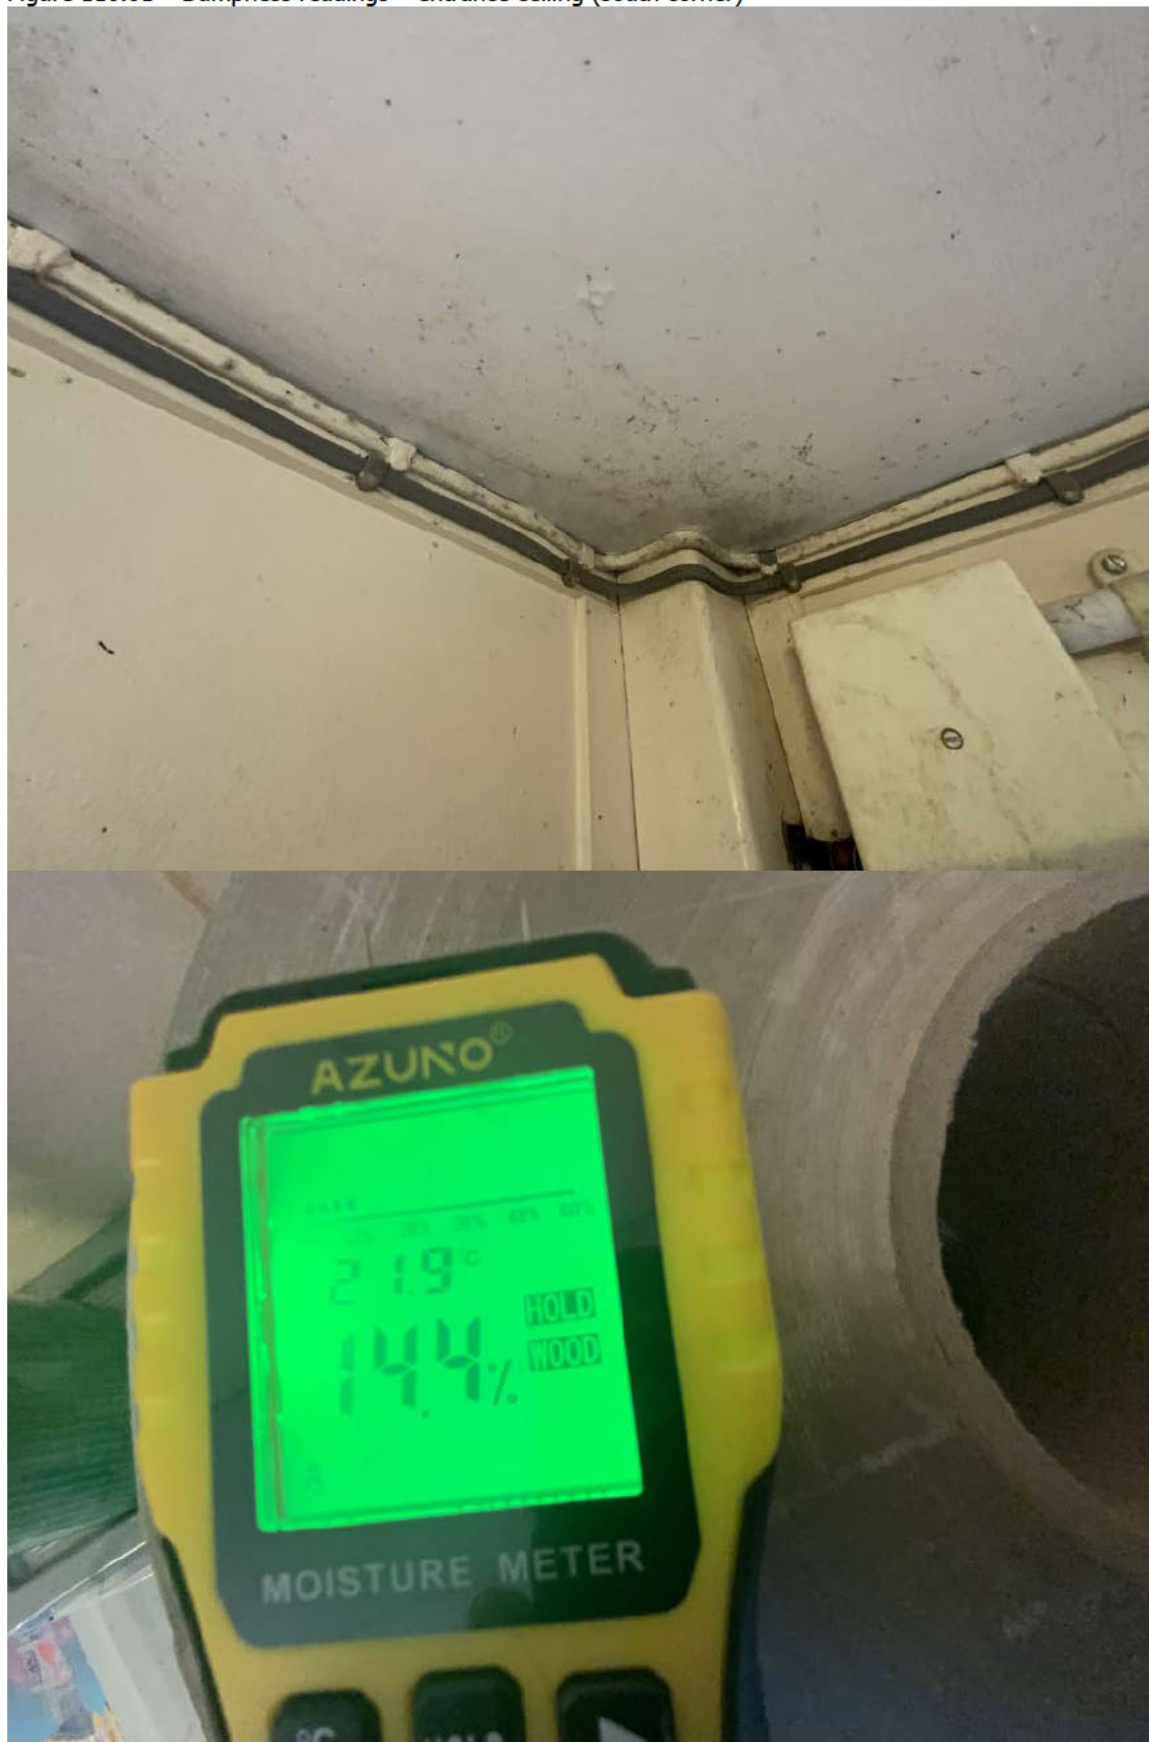
13.01 We observed significant dampness in the property in several places. The range of dampness was between 7.2% and 28.8%. These readings show that there is significant water damage in parts of the walls and floors. Specific locations of these dampness readings is shown in figure 116.

Figure 116.01 – Dampness readings – entrance ceiling (south corner)
