**PRIVATE & CONFIDENTIAL  
BUILDING SURVEY REPORT  
PROPERTY STRANGFORD AREA  
St Joseph's Primary School  
Date of Inspection May 2023  
Weather: Clear  
Ref: 20230524**

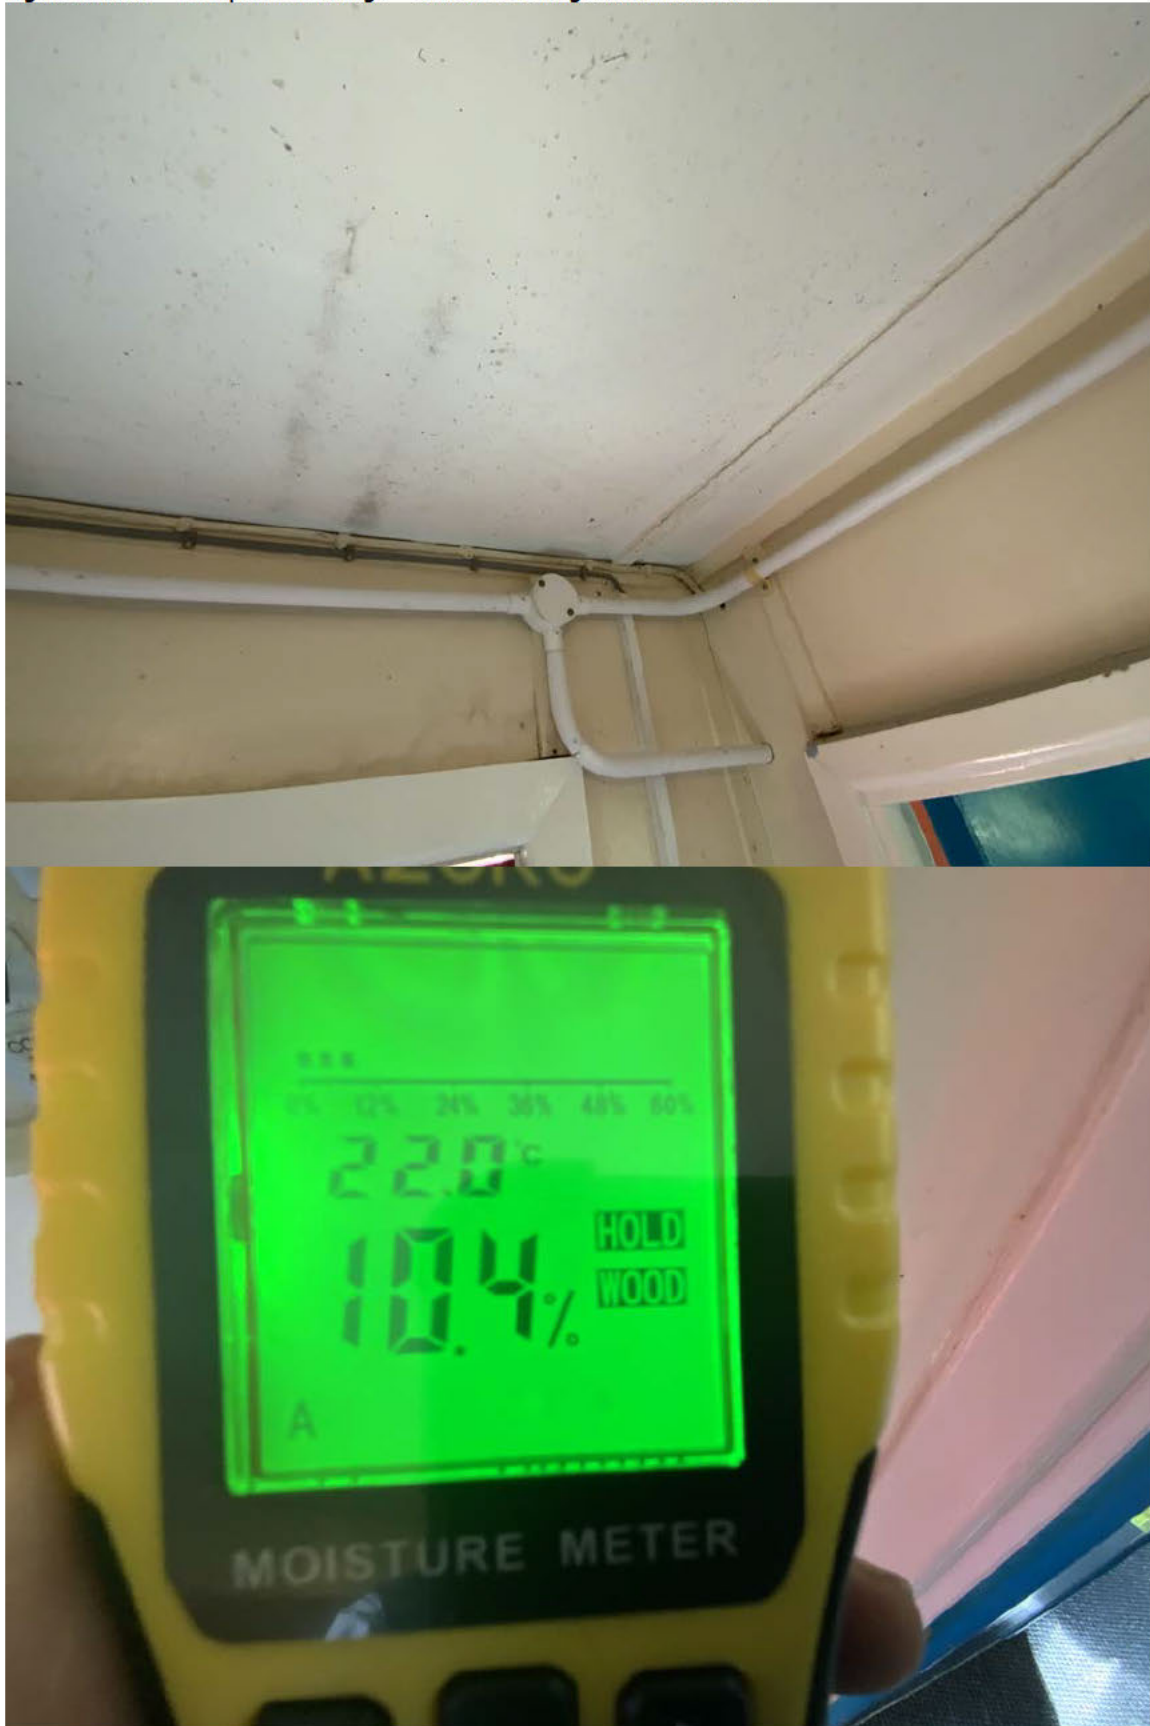
13.01 We observed significant dampness in the property in several places. The range of dampness was between 7.2% and 28.8%. These readings show that there is significant water damage in parts of the walls and floors. Specific locations of these dampness readings is shown in figure 116.

Figure 116.02 – Dampness readings – entrance ceiling black mould area

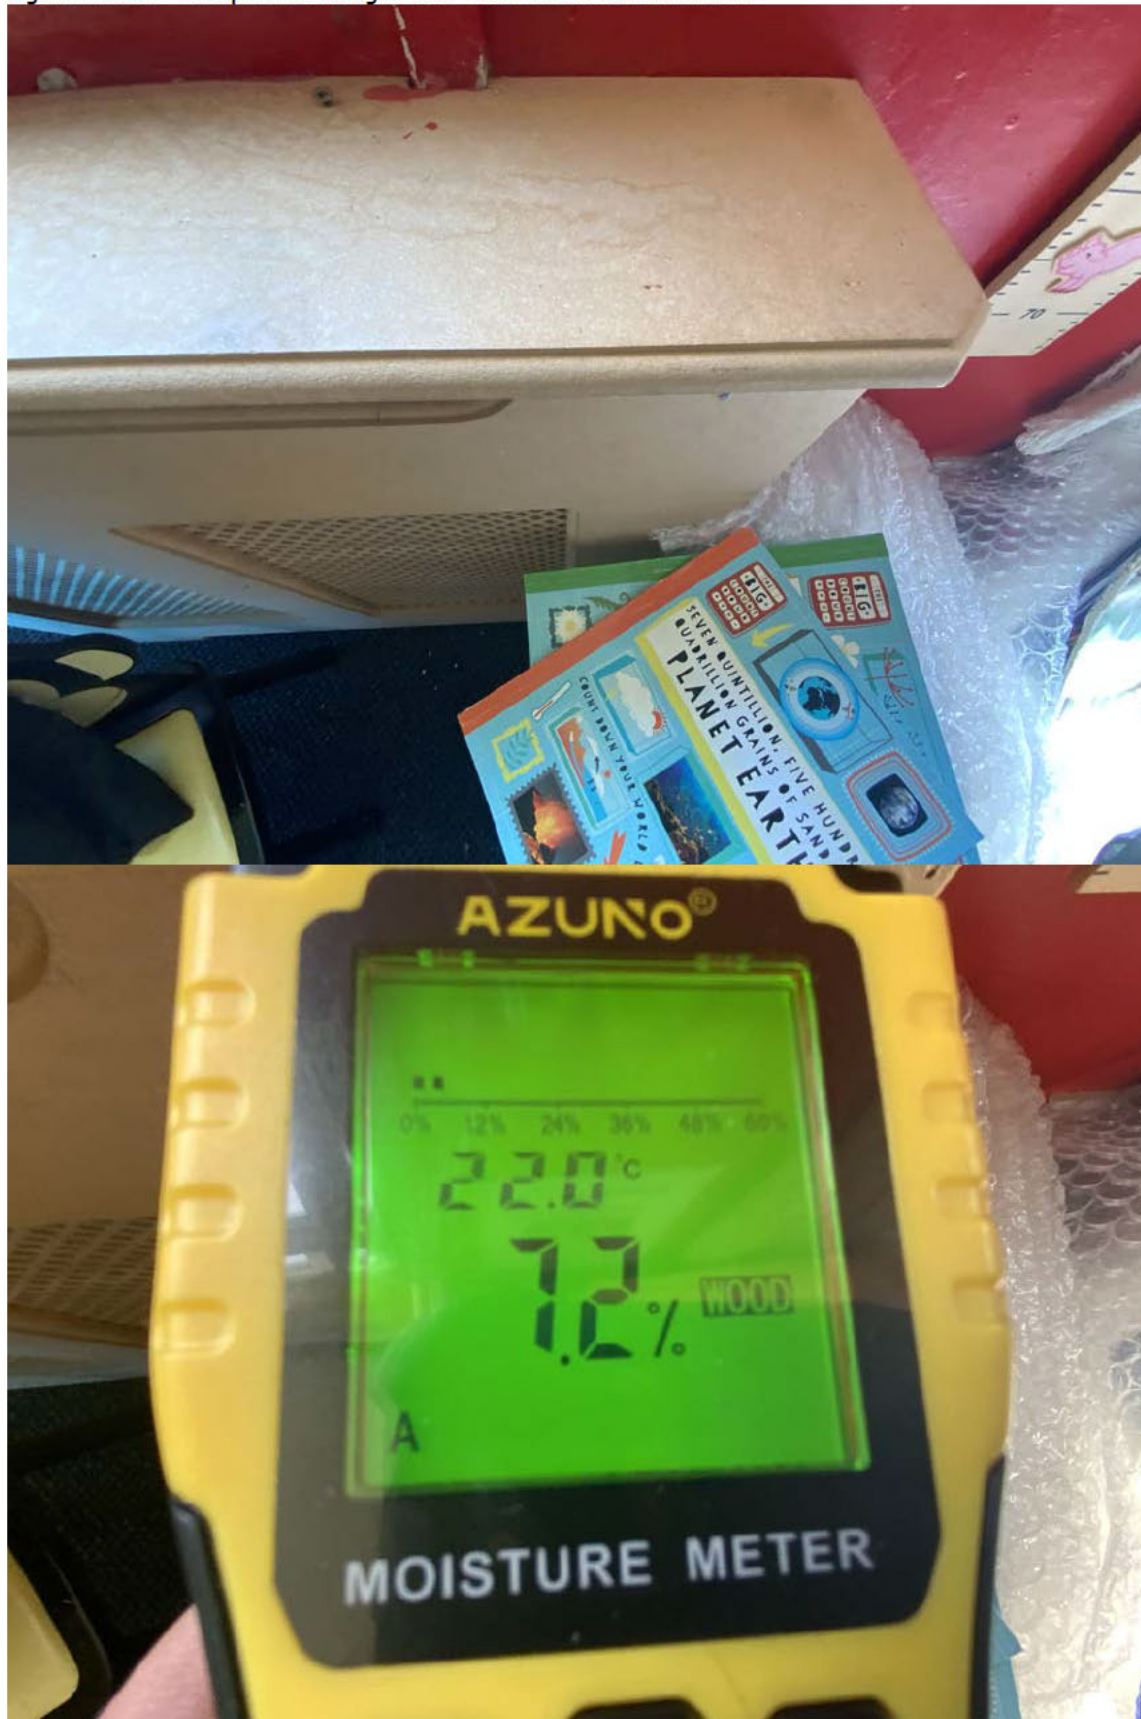
Figure 116.03 – Dampness readings – mdf enclosure of electric heater

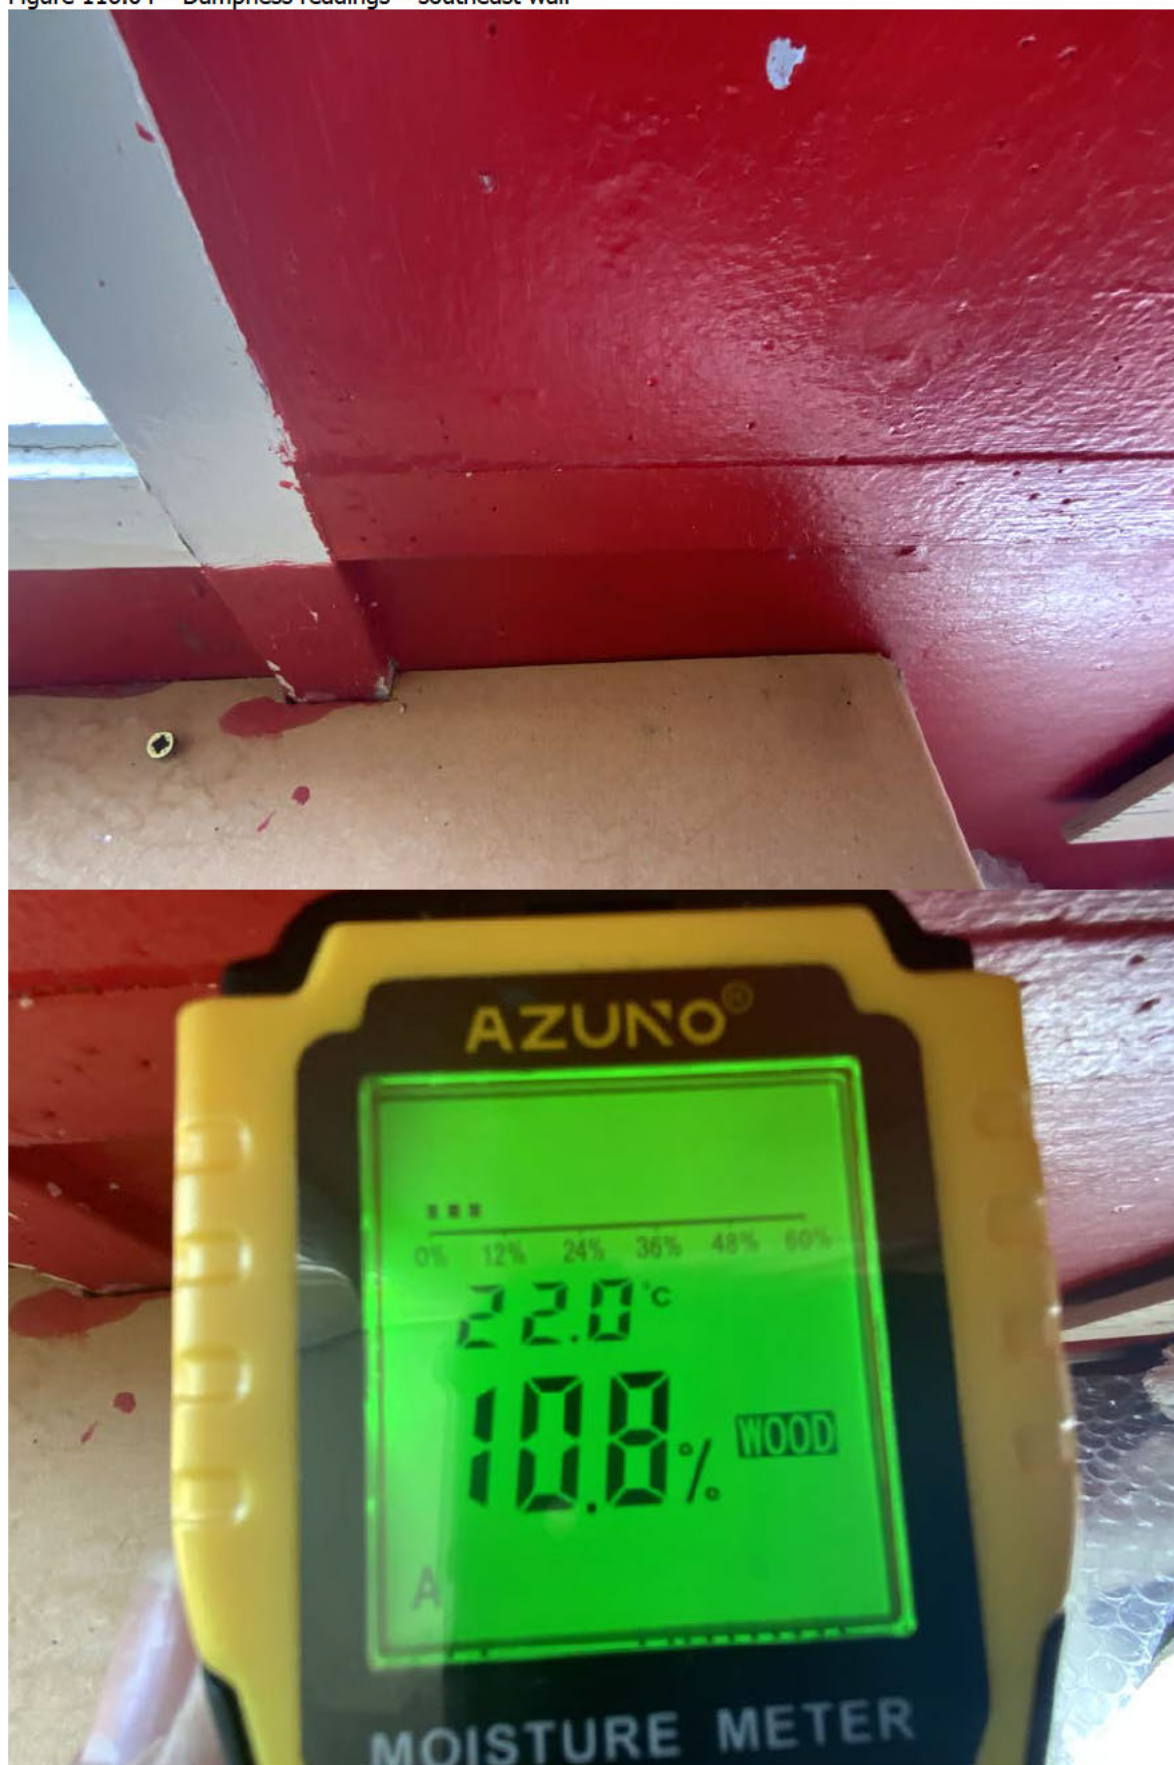
Figure 116.04 – Dampness readings – southeast wall

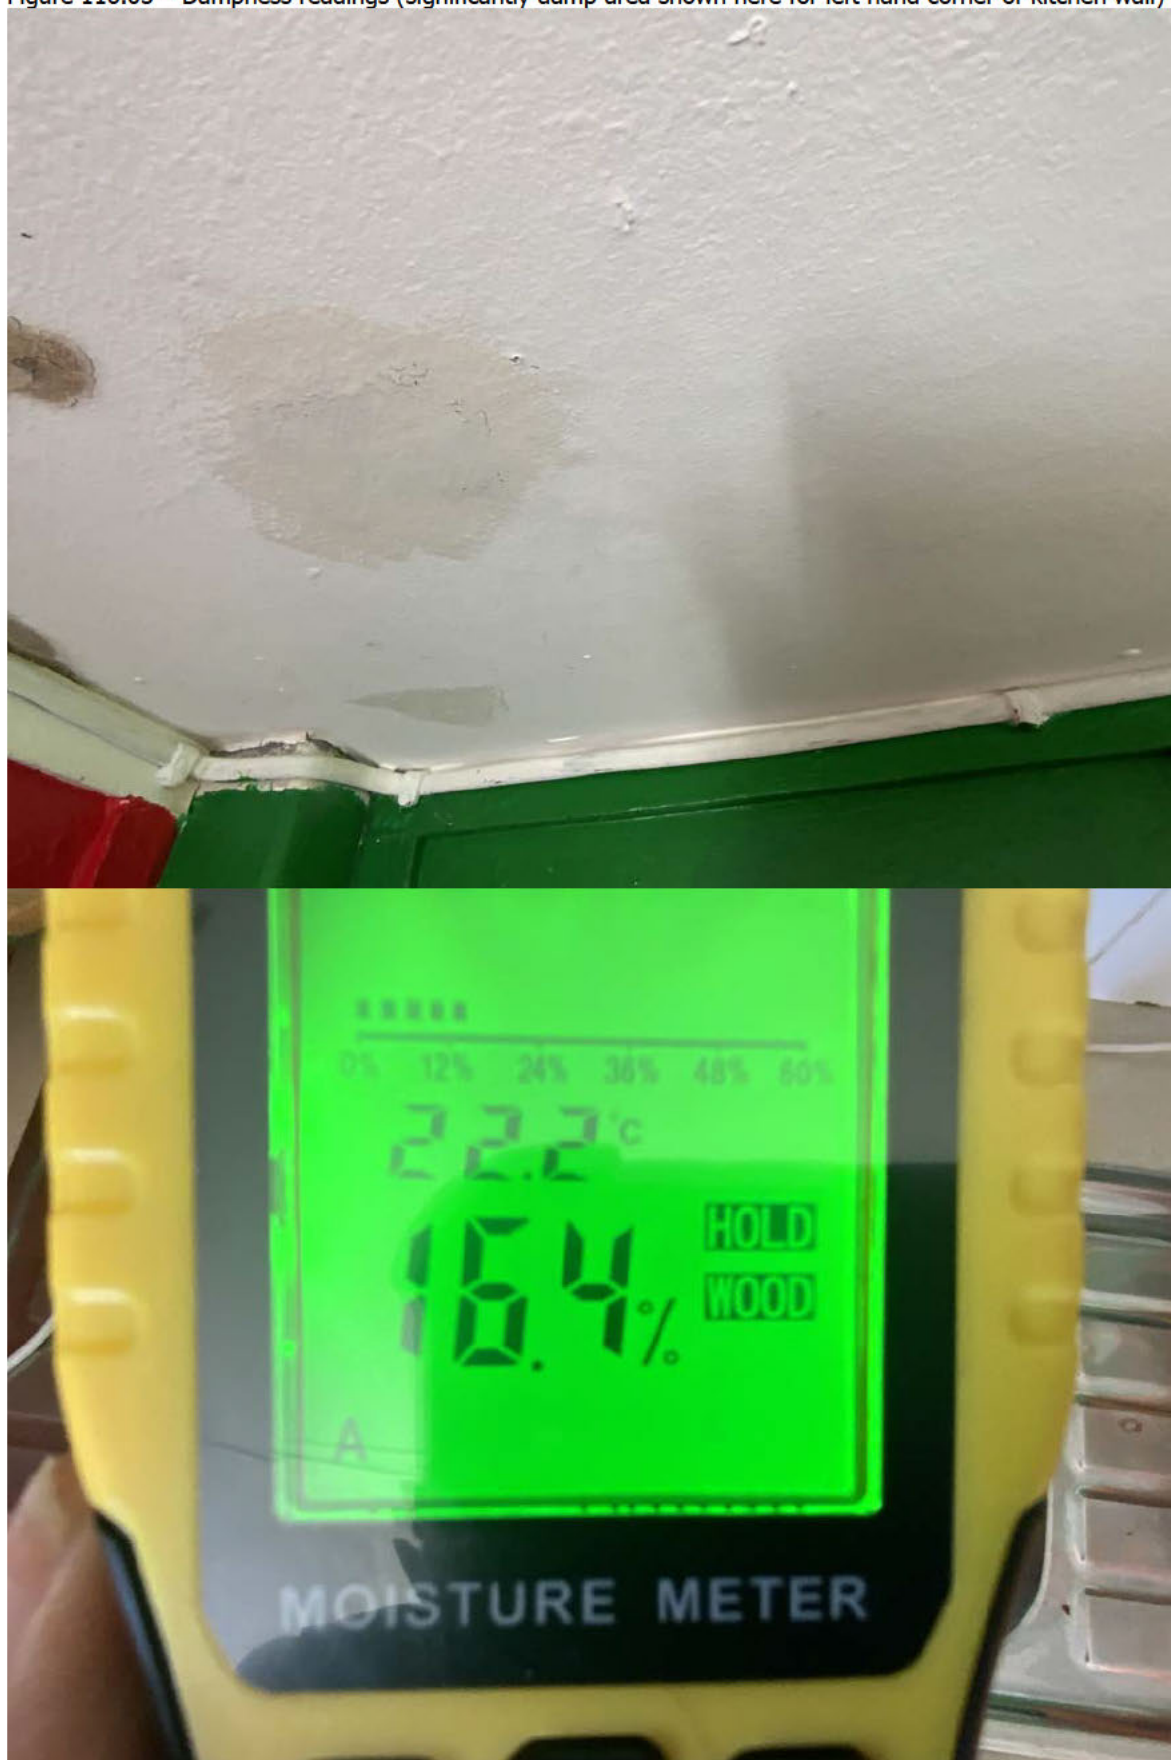
Figure 116.05 – Dampness readings (significantly damp area shown here for left hand corner of kitchen wall)

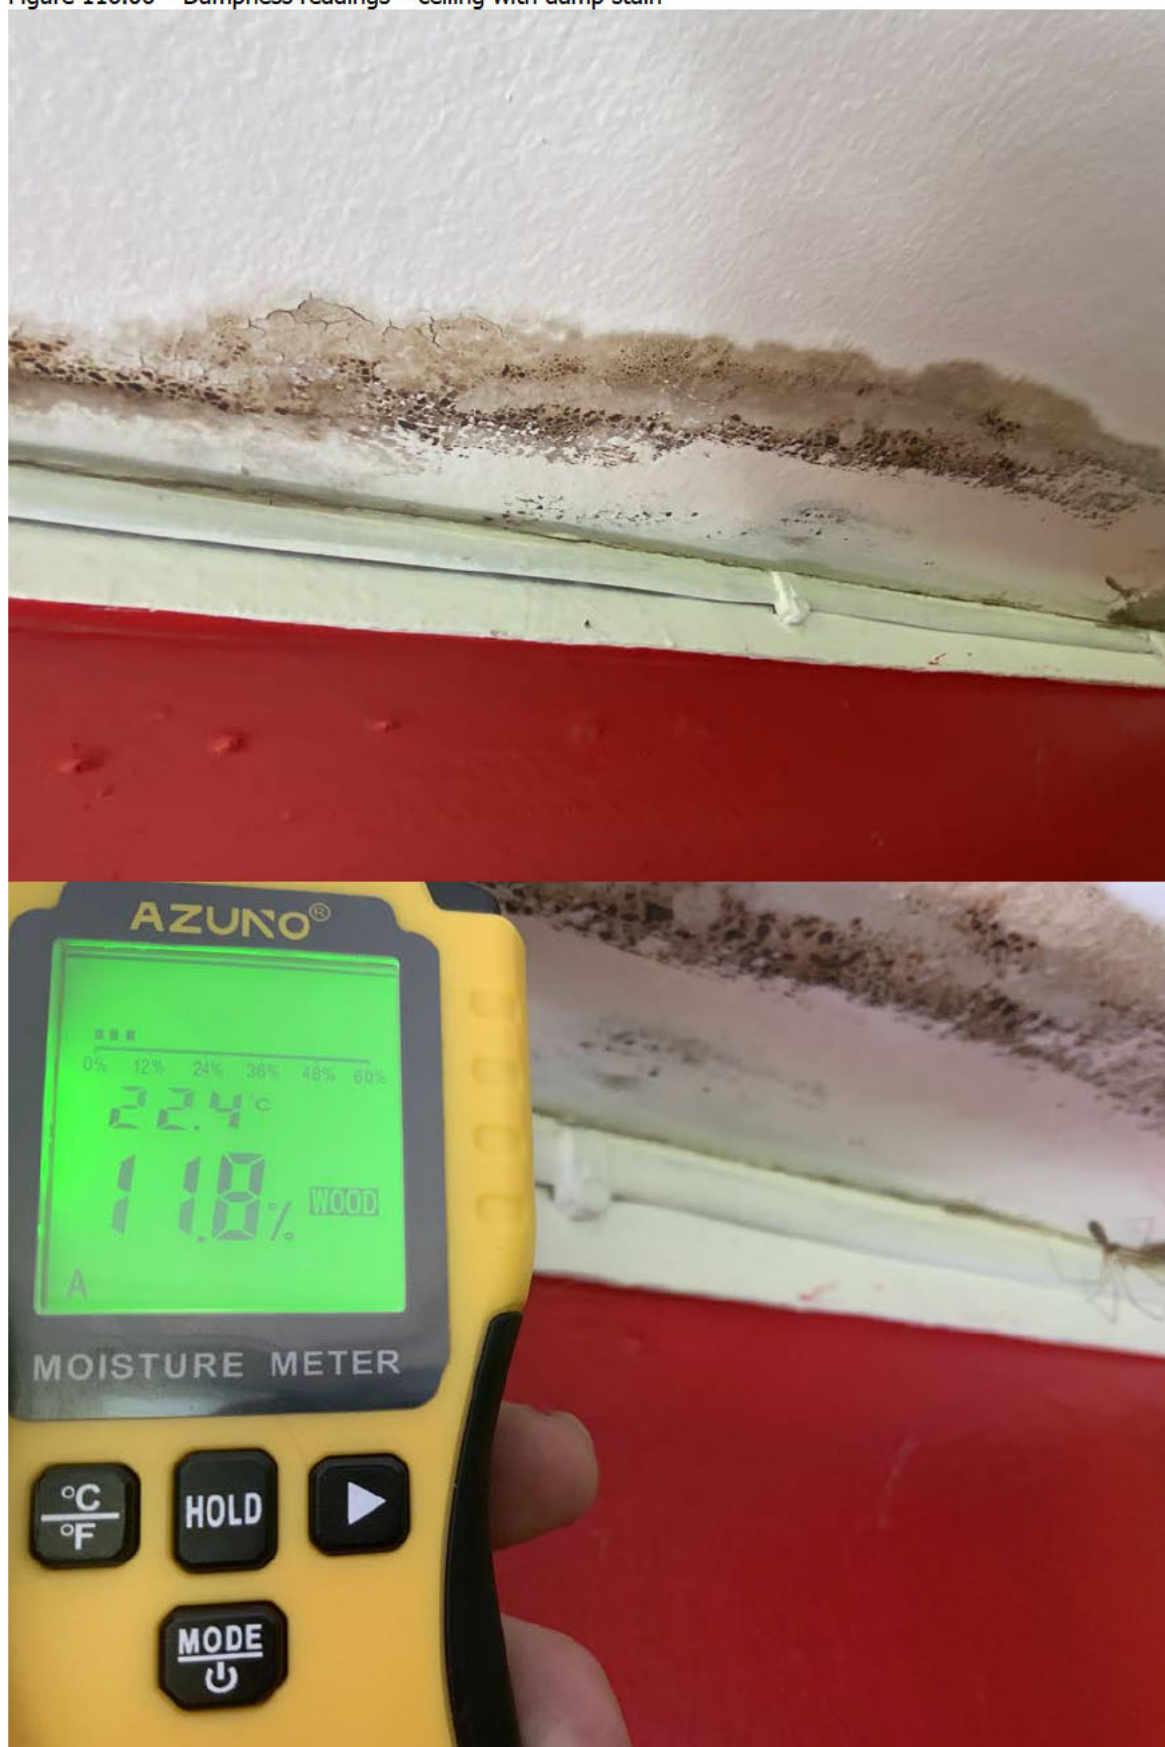
Figure 116.06 – Dampness readings – ceiling with damp stain

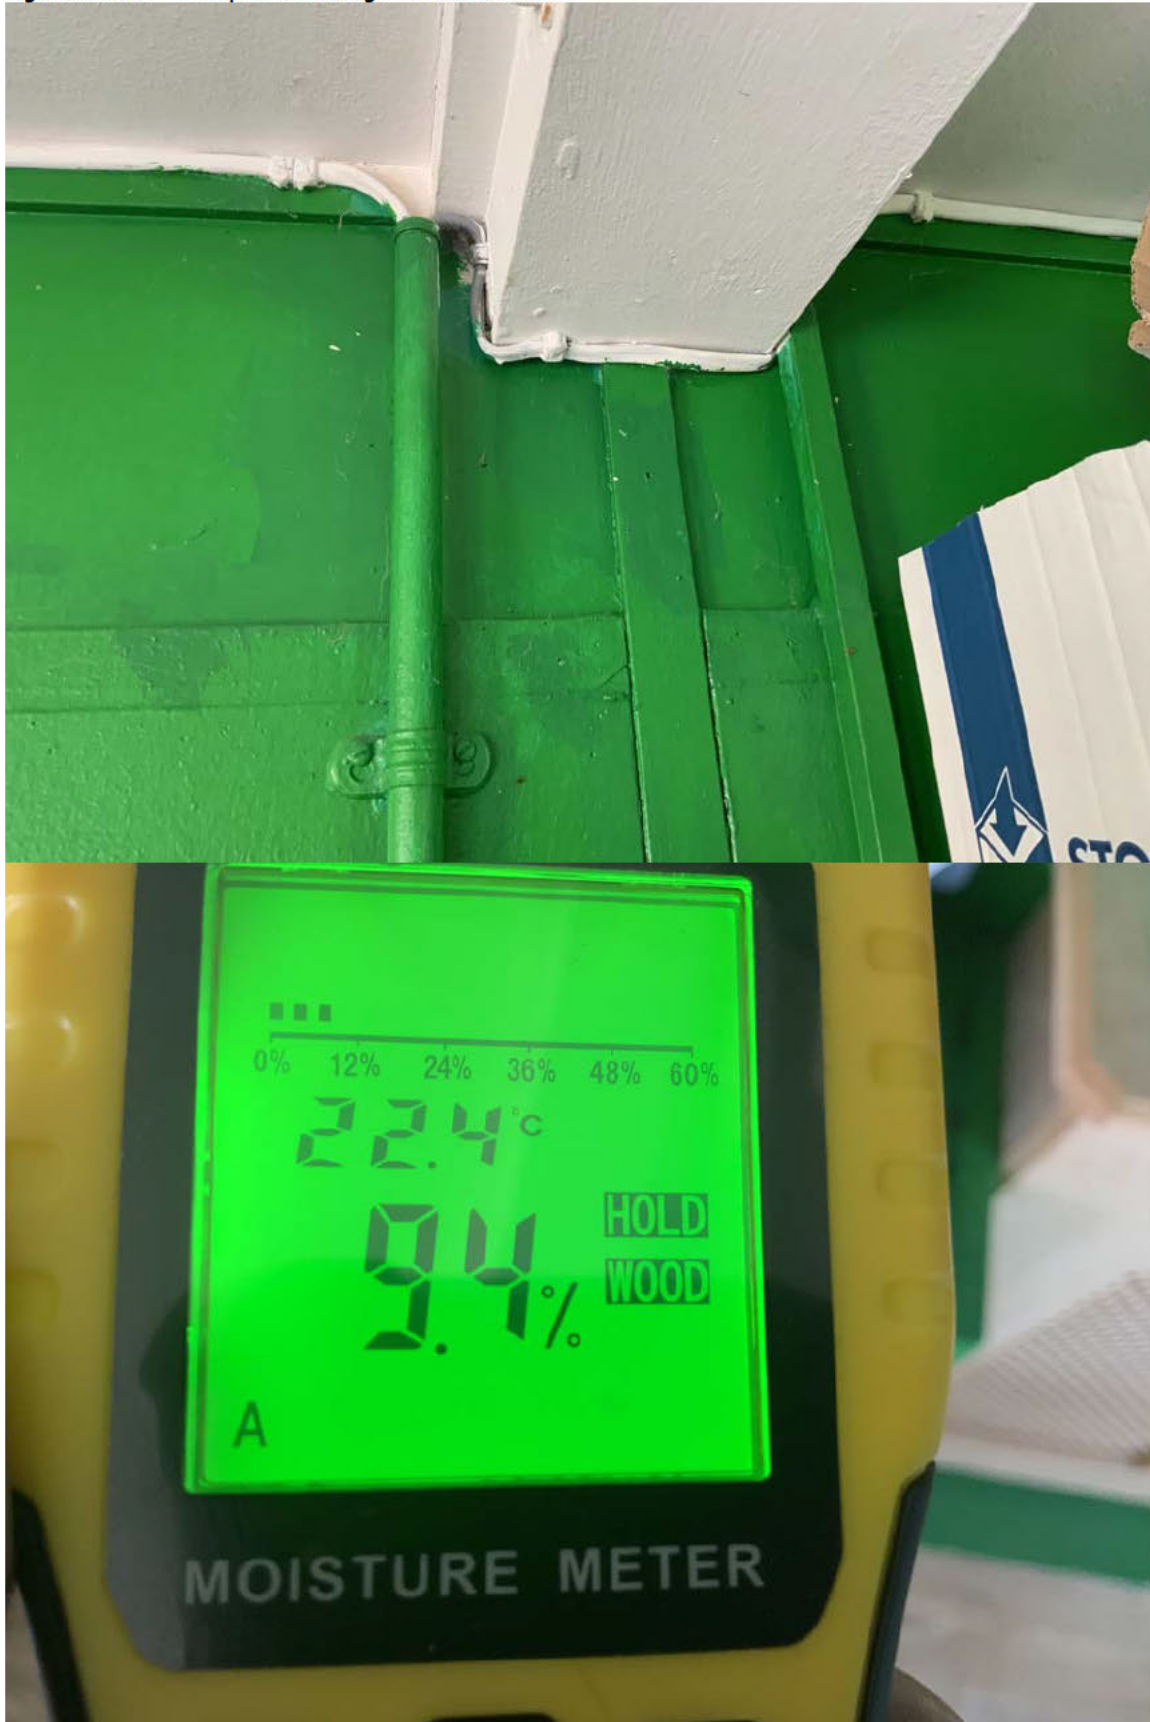
Figure 116.07 – Dampness readings – southwest wall

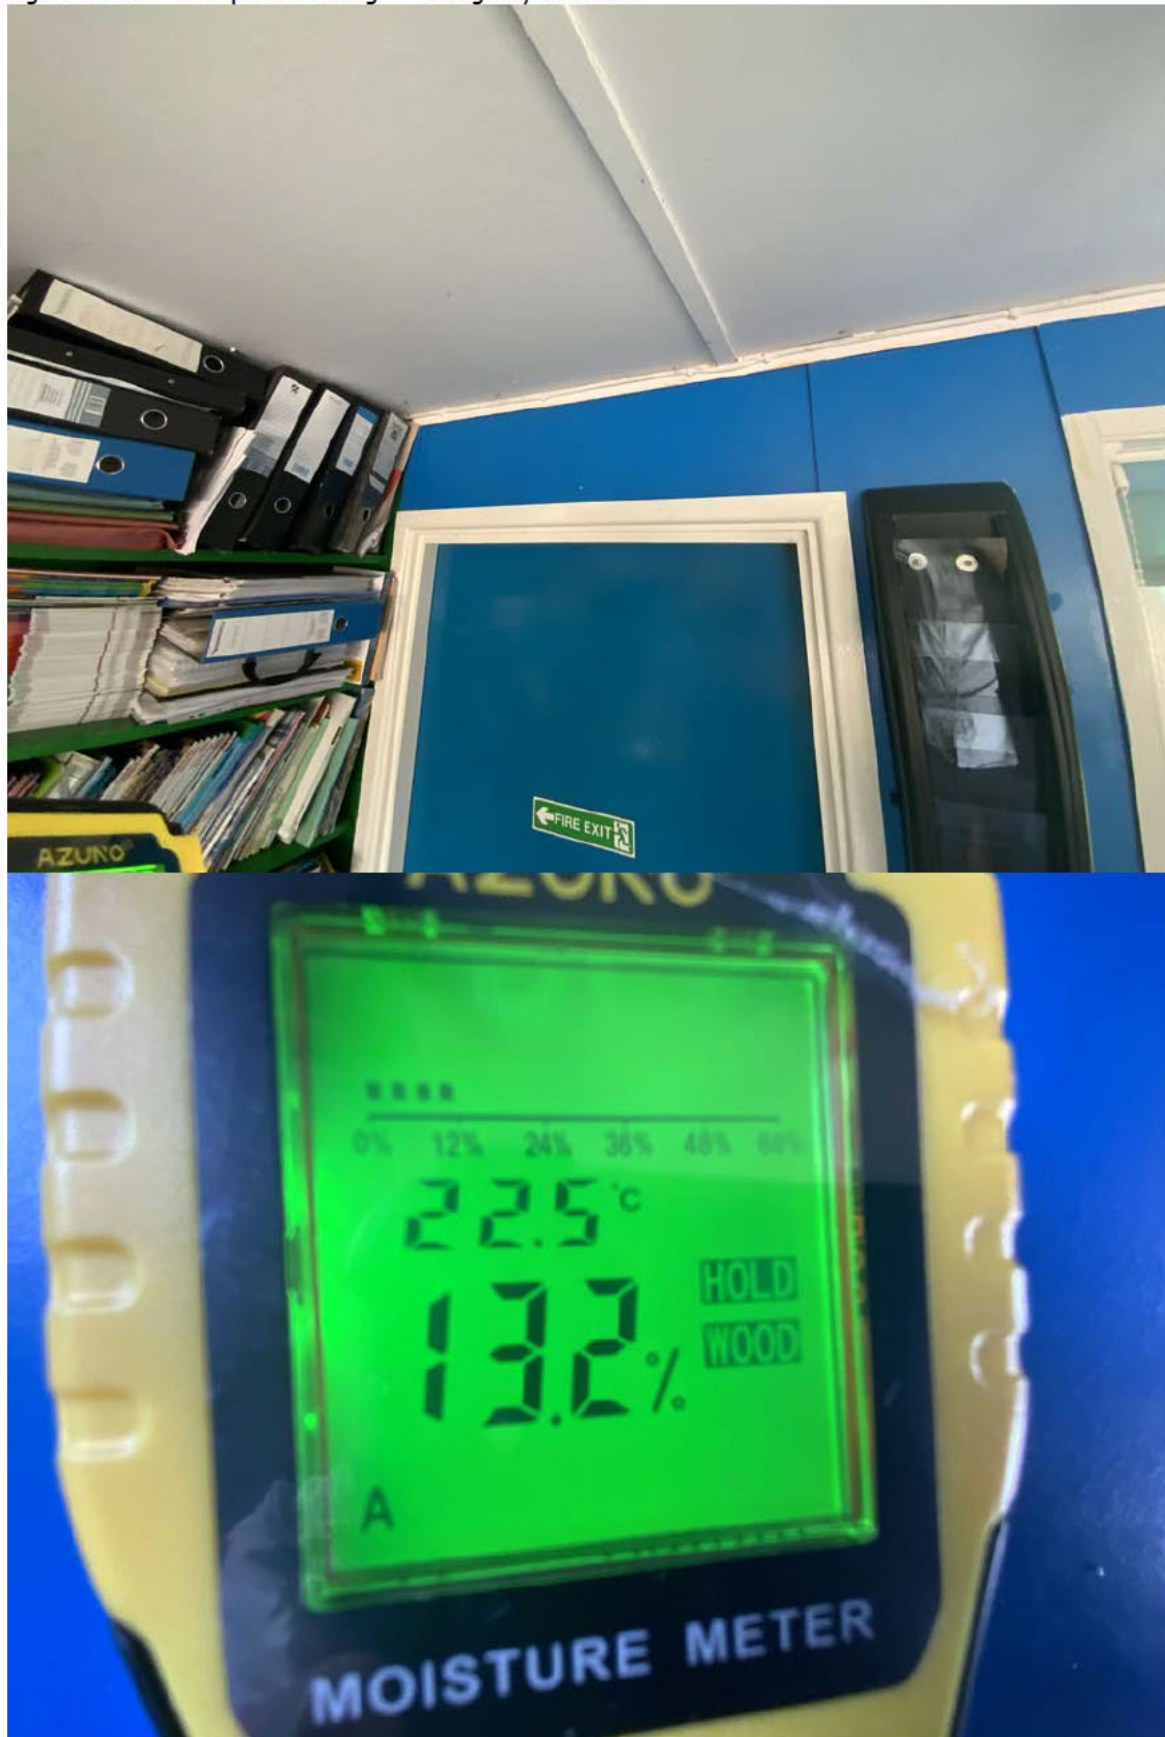
Figure 116.08 – Dampness readings – emergency exit wall

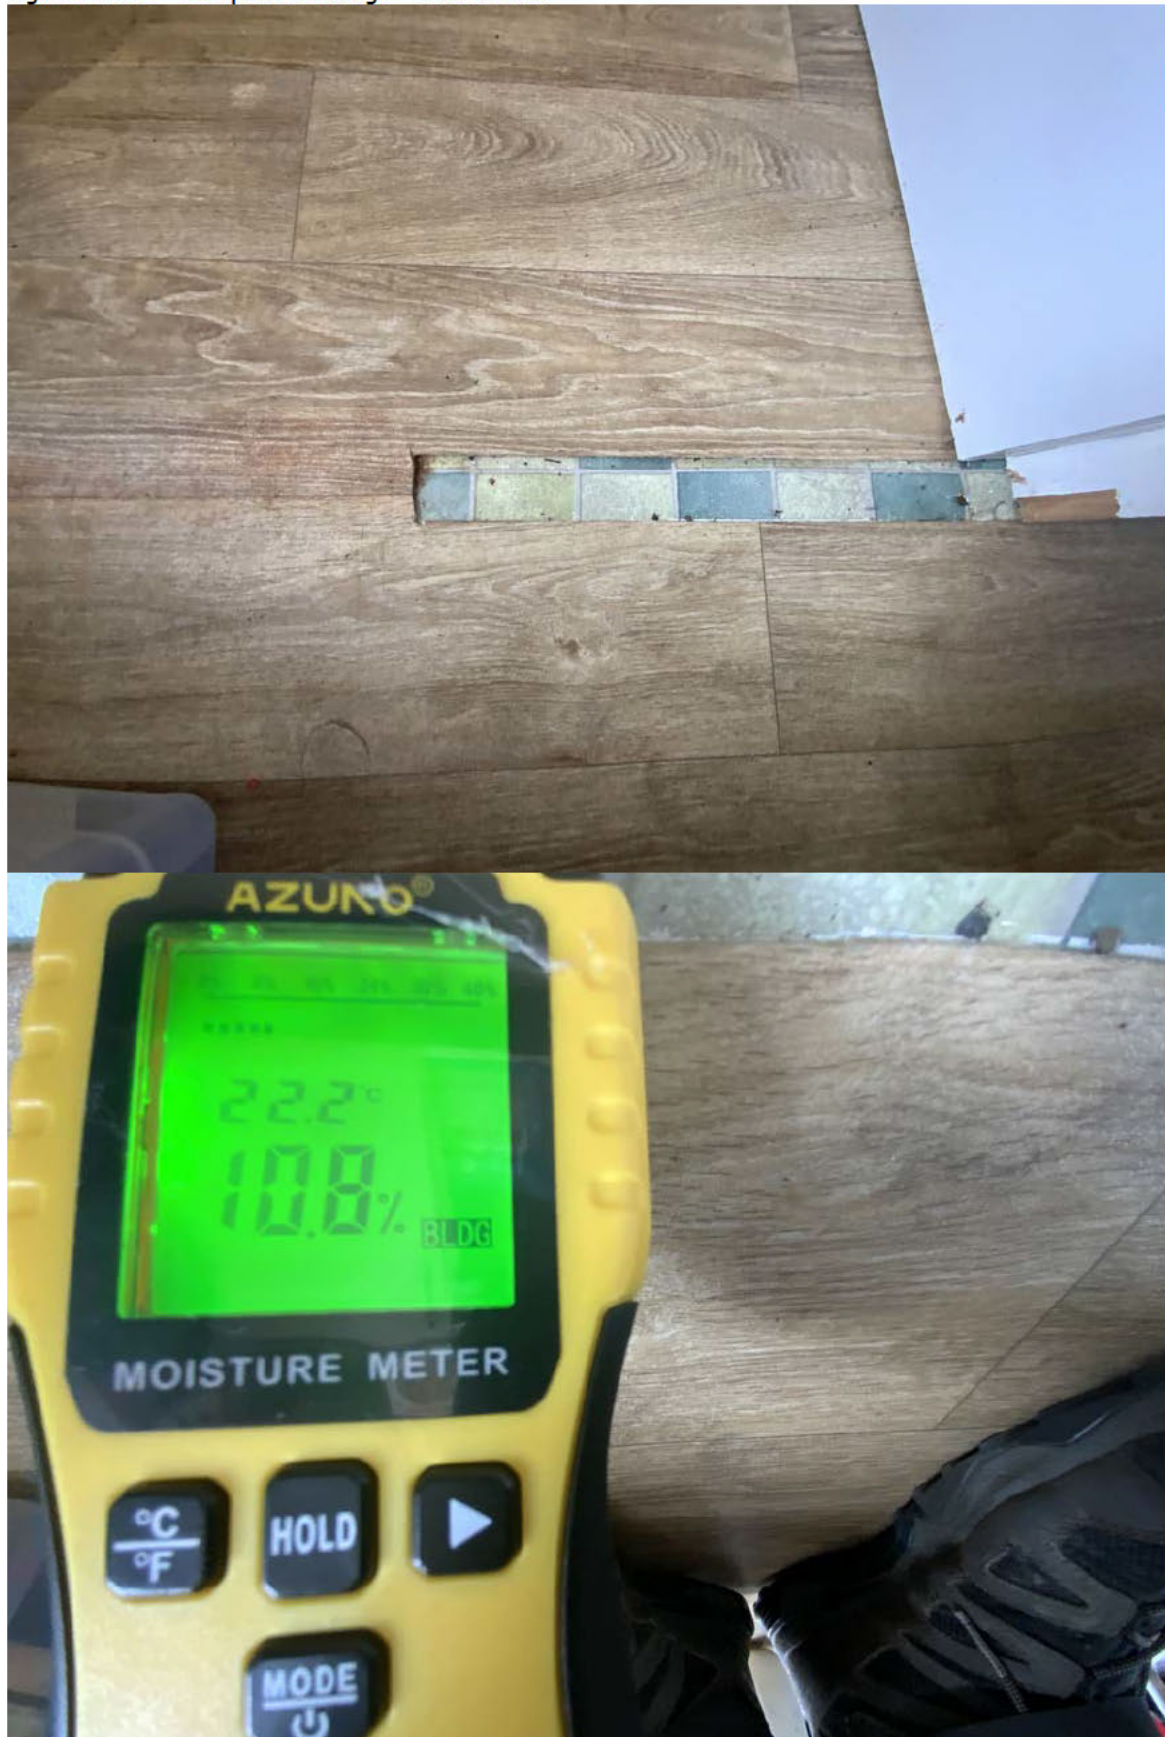
Figure 116.09 – Dampness readings – kitchen floor

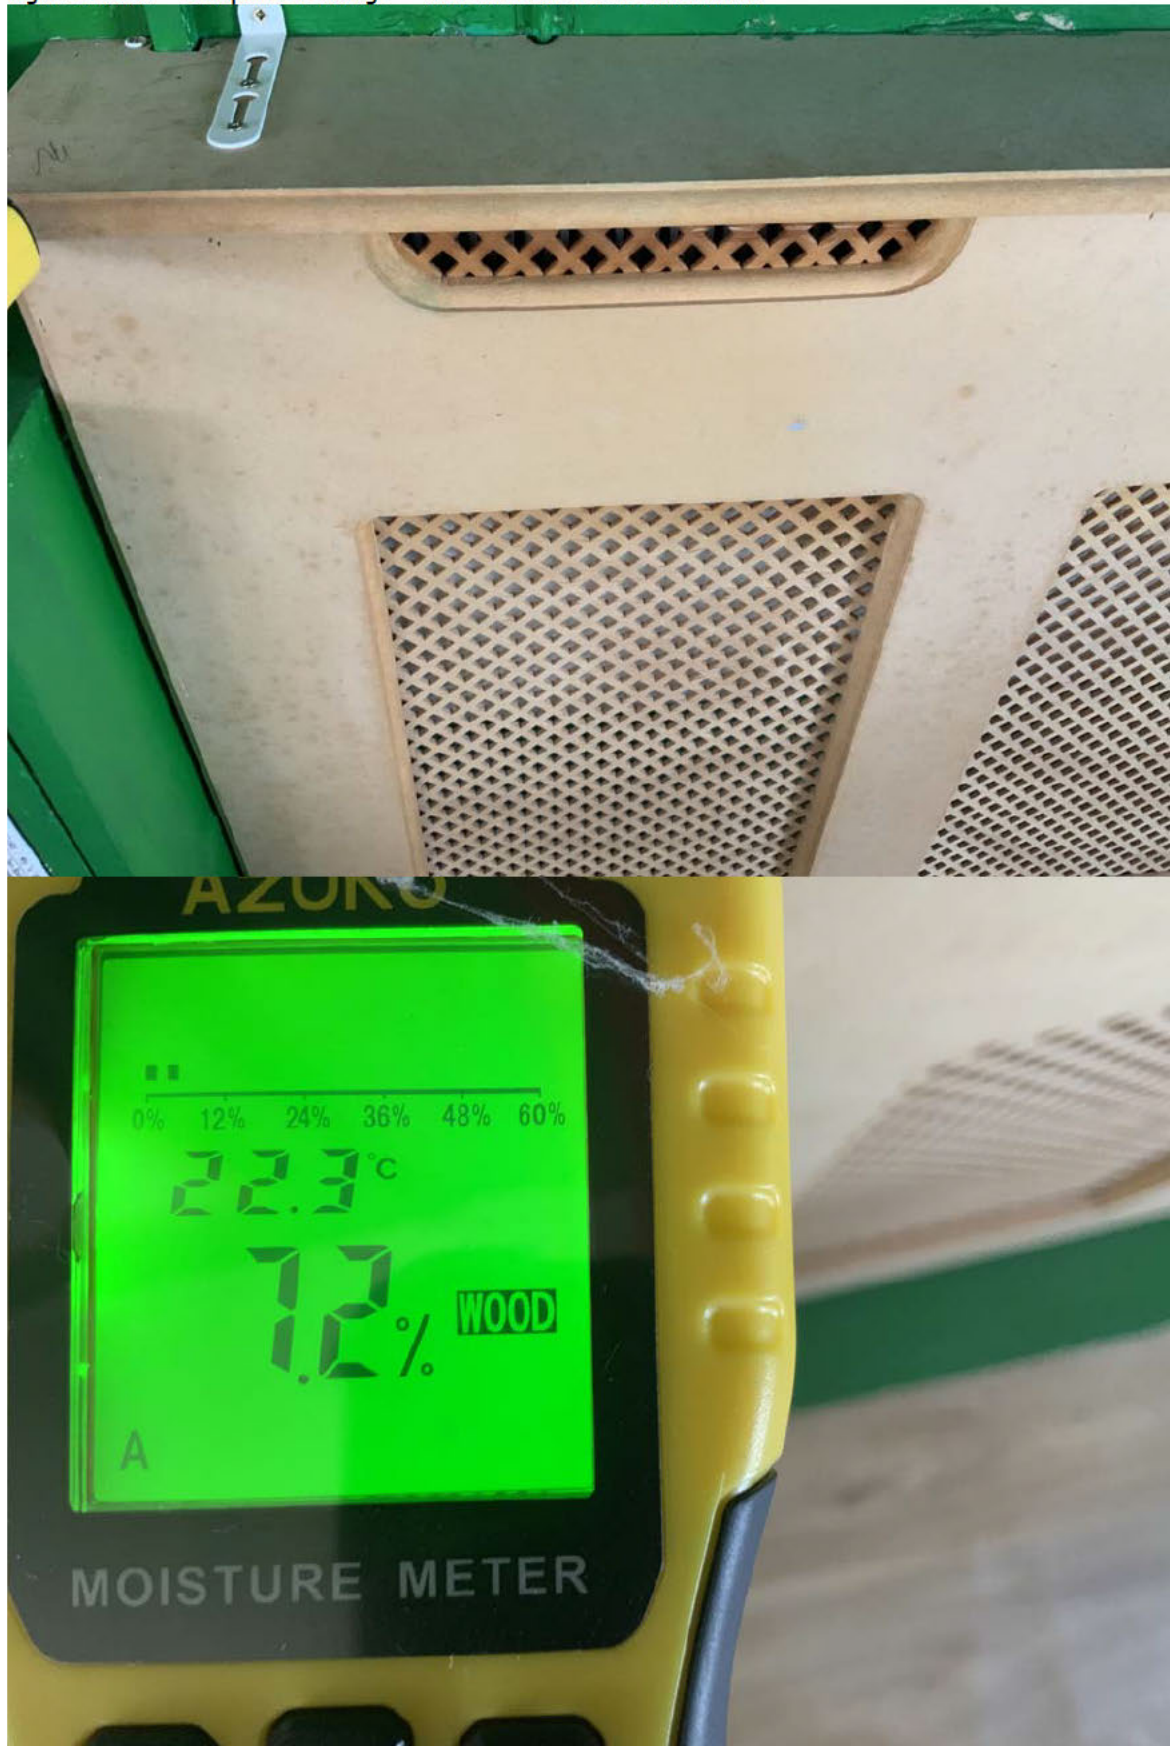
Figure 116.10 – Dampness readings – mdf enclosure of electric heater

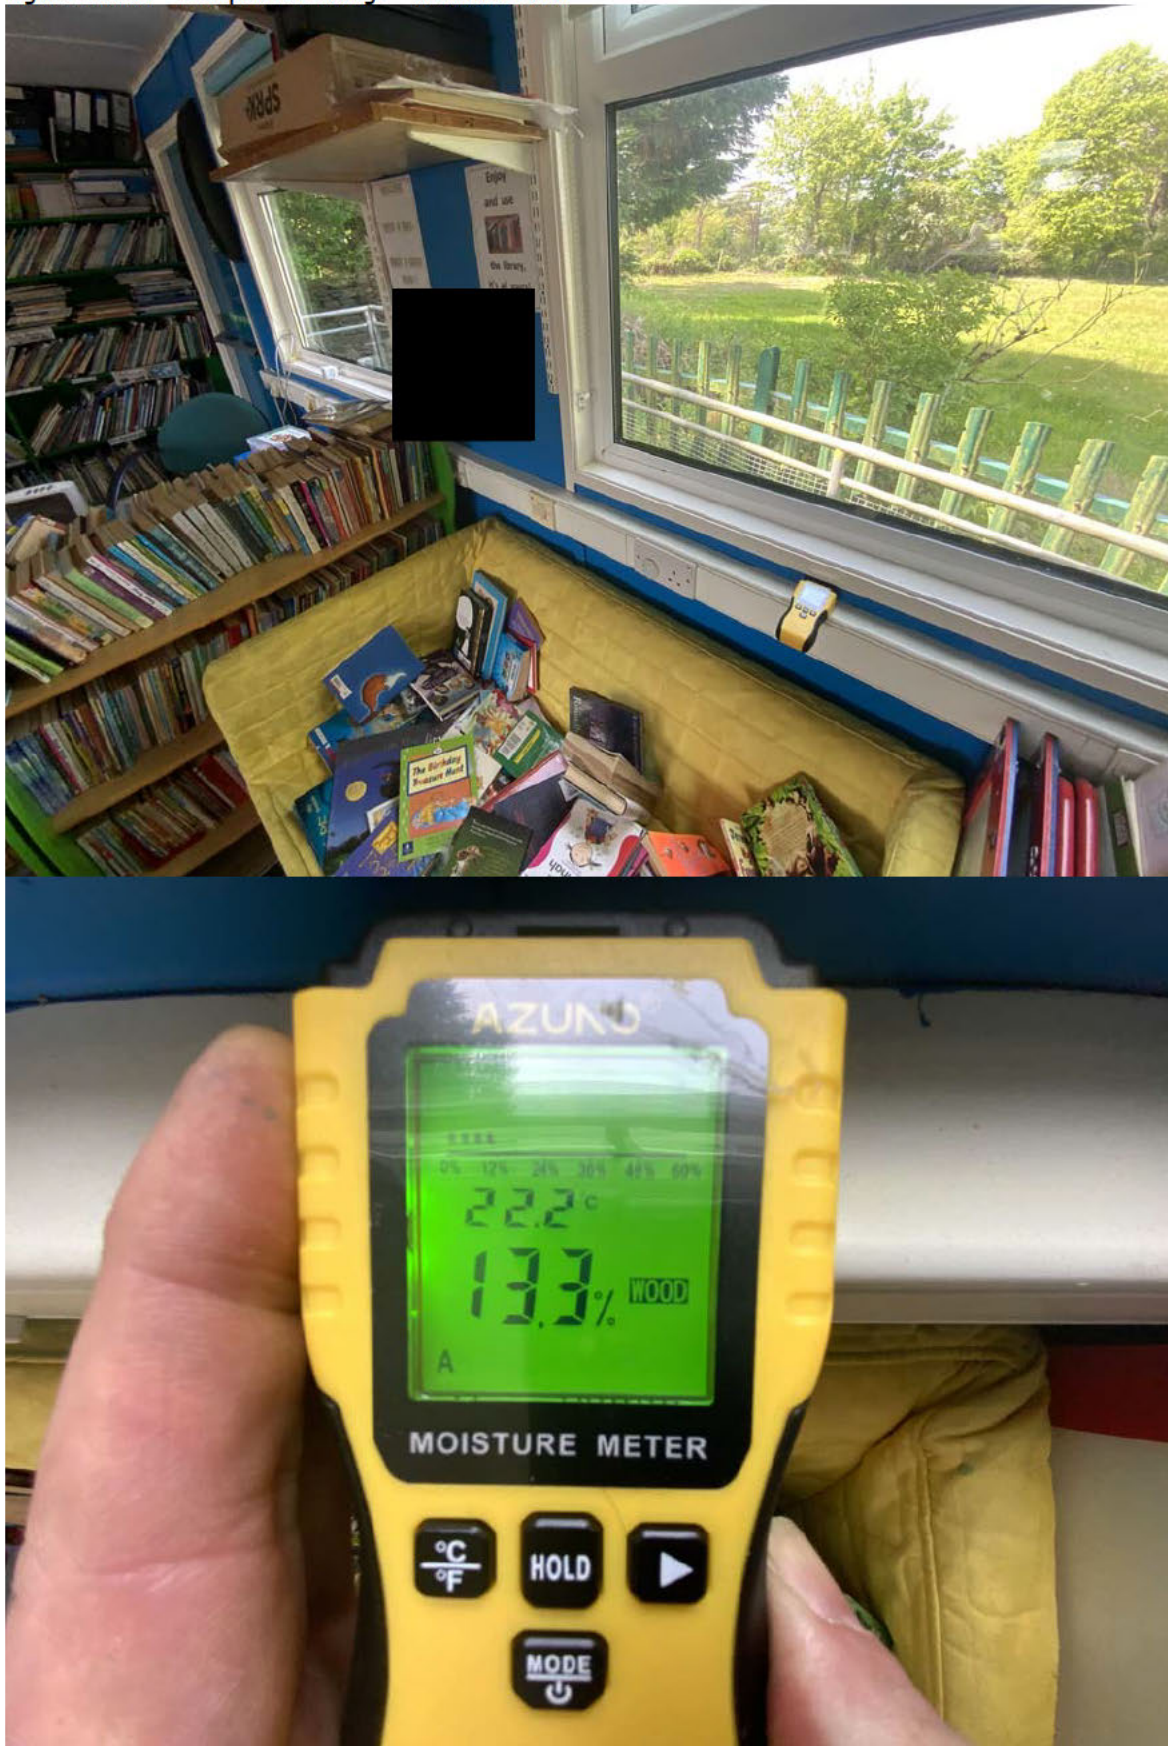
Figure 116.11 – Dampness readings – northwest wall

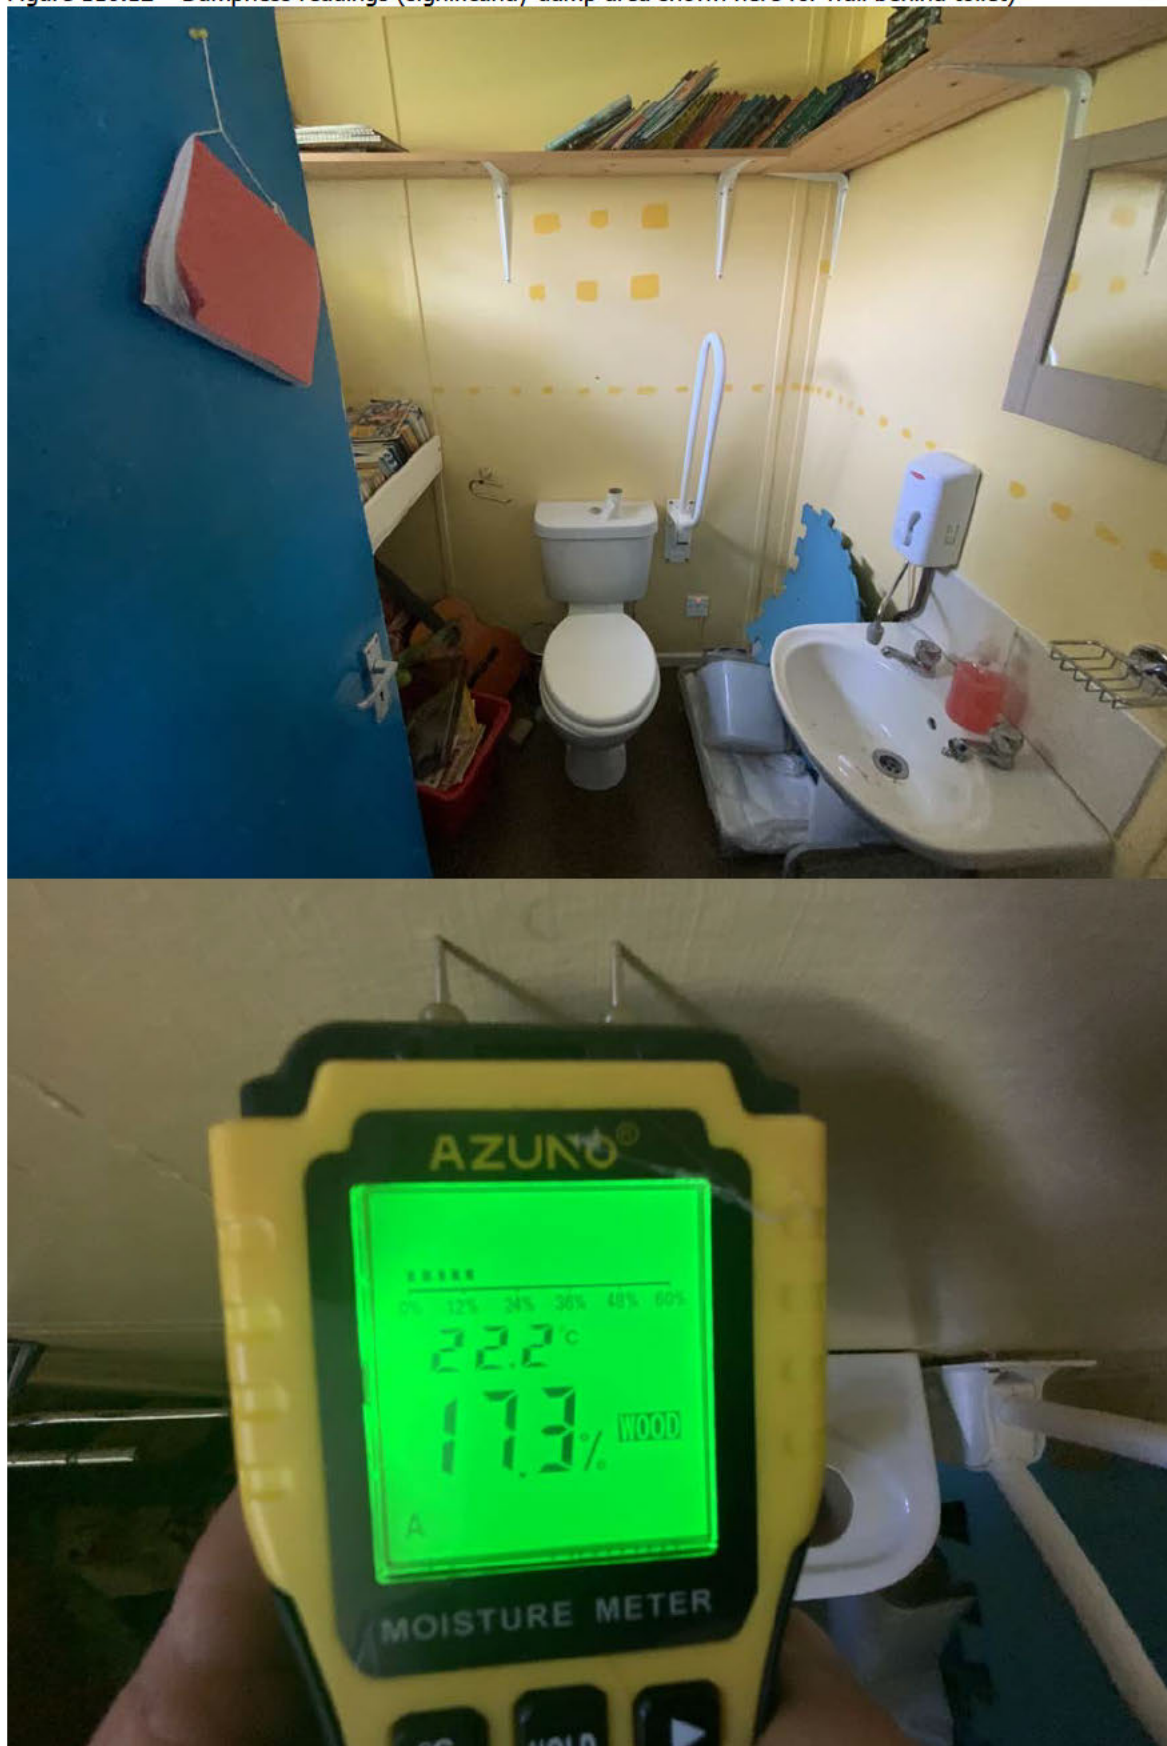
Figure 116.12 – Dampness readings (significantly damp area shown here for wall behind toilet)
