**PRIVATE & CONFIDENTIAL  
BUILDING SURVEY REPORT  
PROPERTY STRANGFORD AREA  
St Joseph's Primary School  
Date of Inspection May 2023  
Weather: Clear  
Ref: 20230524**

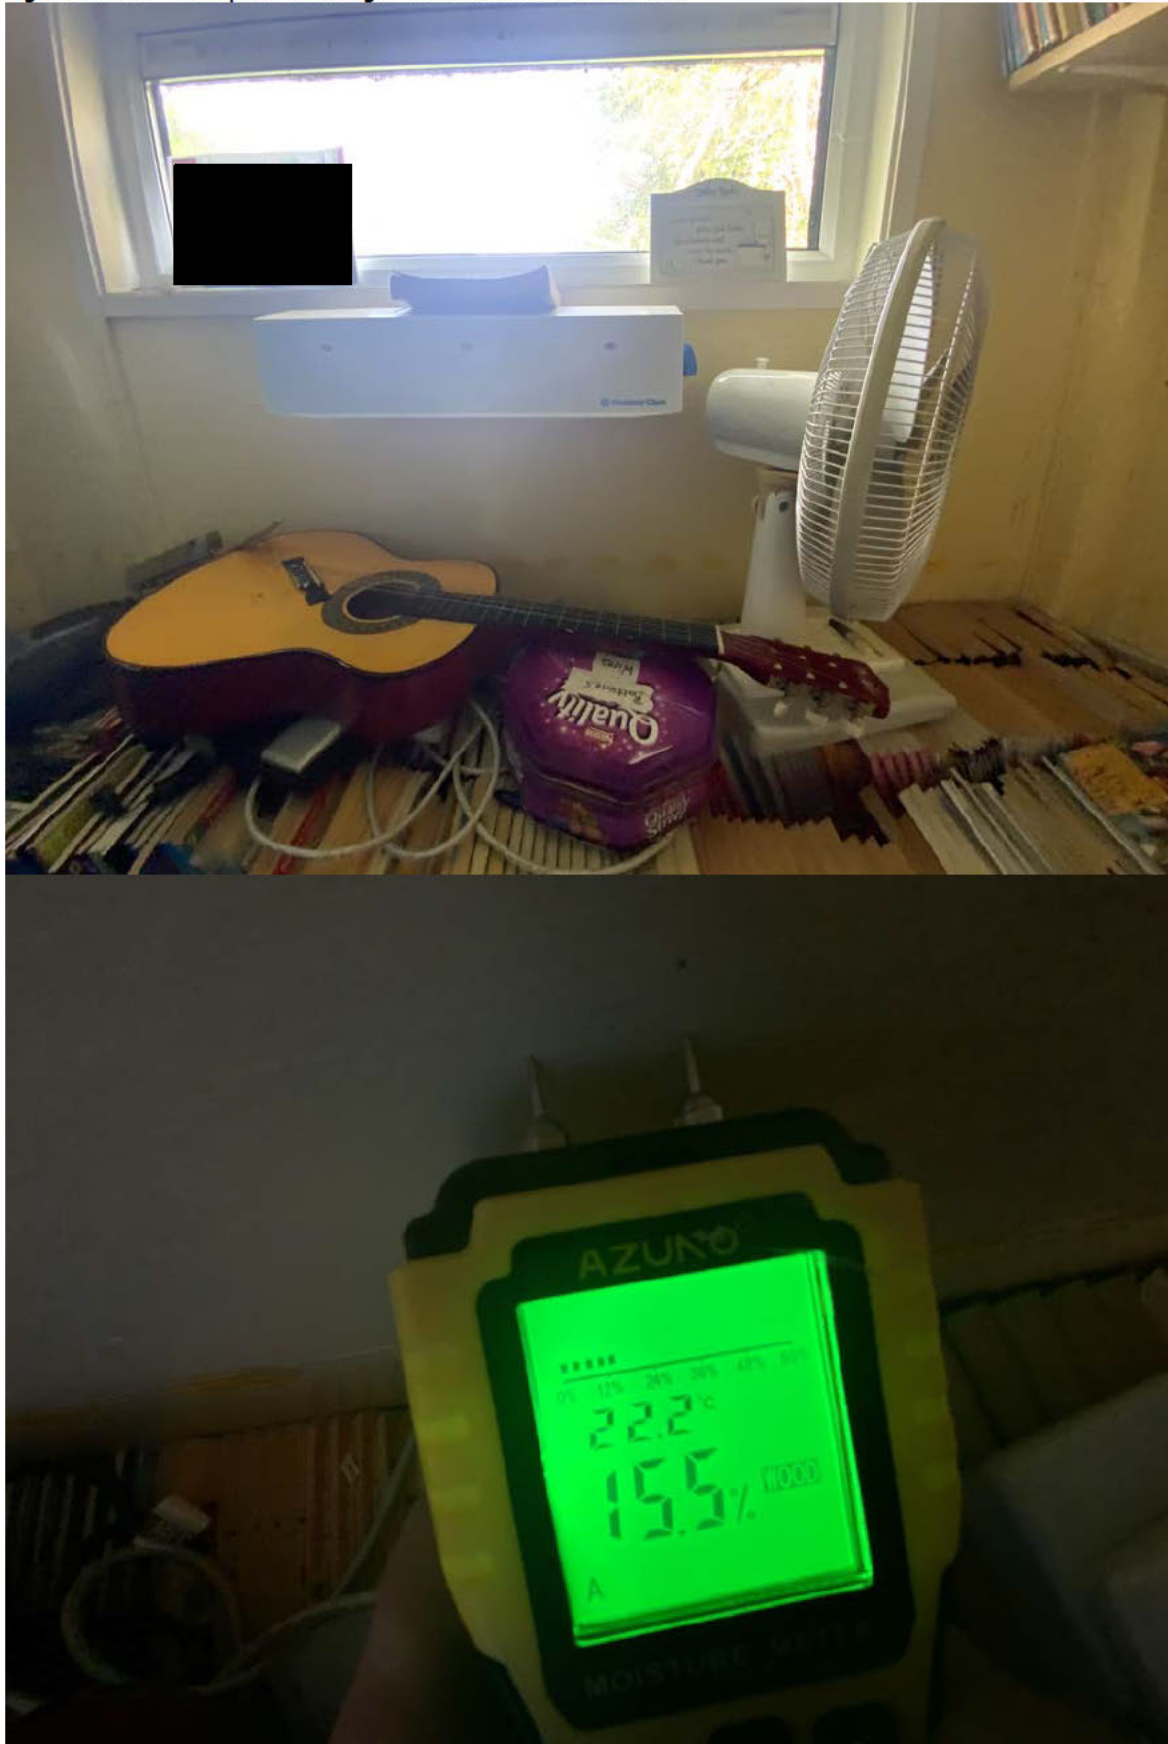
13.01 We observed significant dampness in the property in several places. The range of dampness was between 7.2% and 28.8%. These readings show that there is significant water damage in parts of the walls and floors. Specific locations of these dampness readings is shown in figure 116.

Figure 116.13 – Dampness readings – northwest wall toilet area

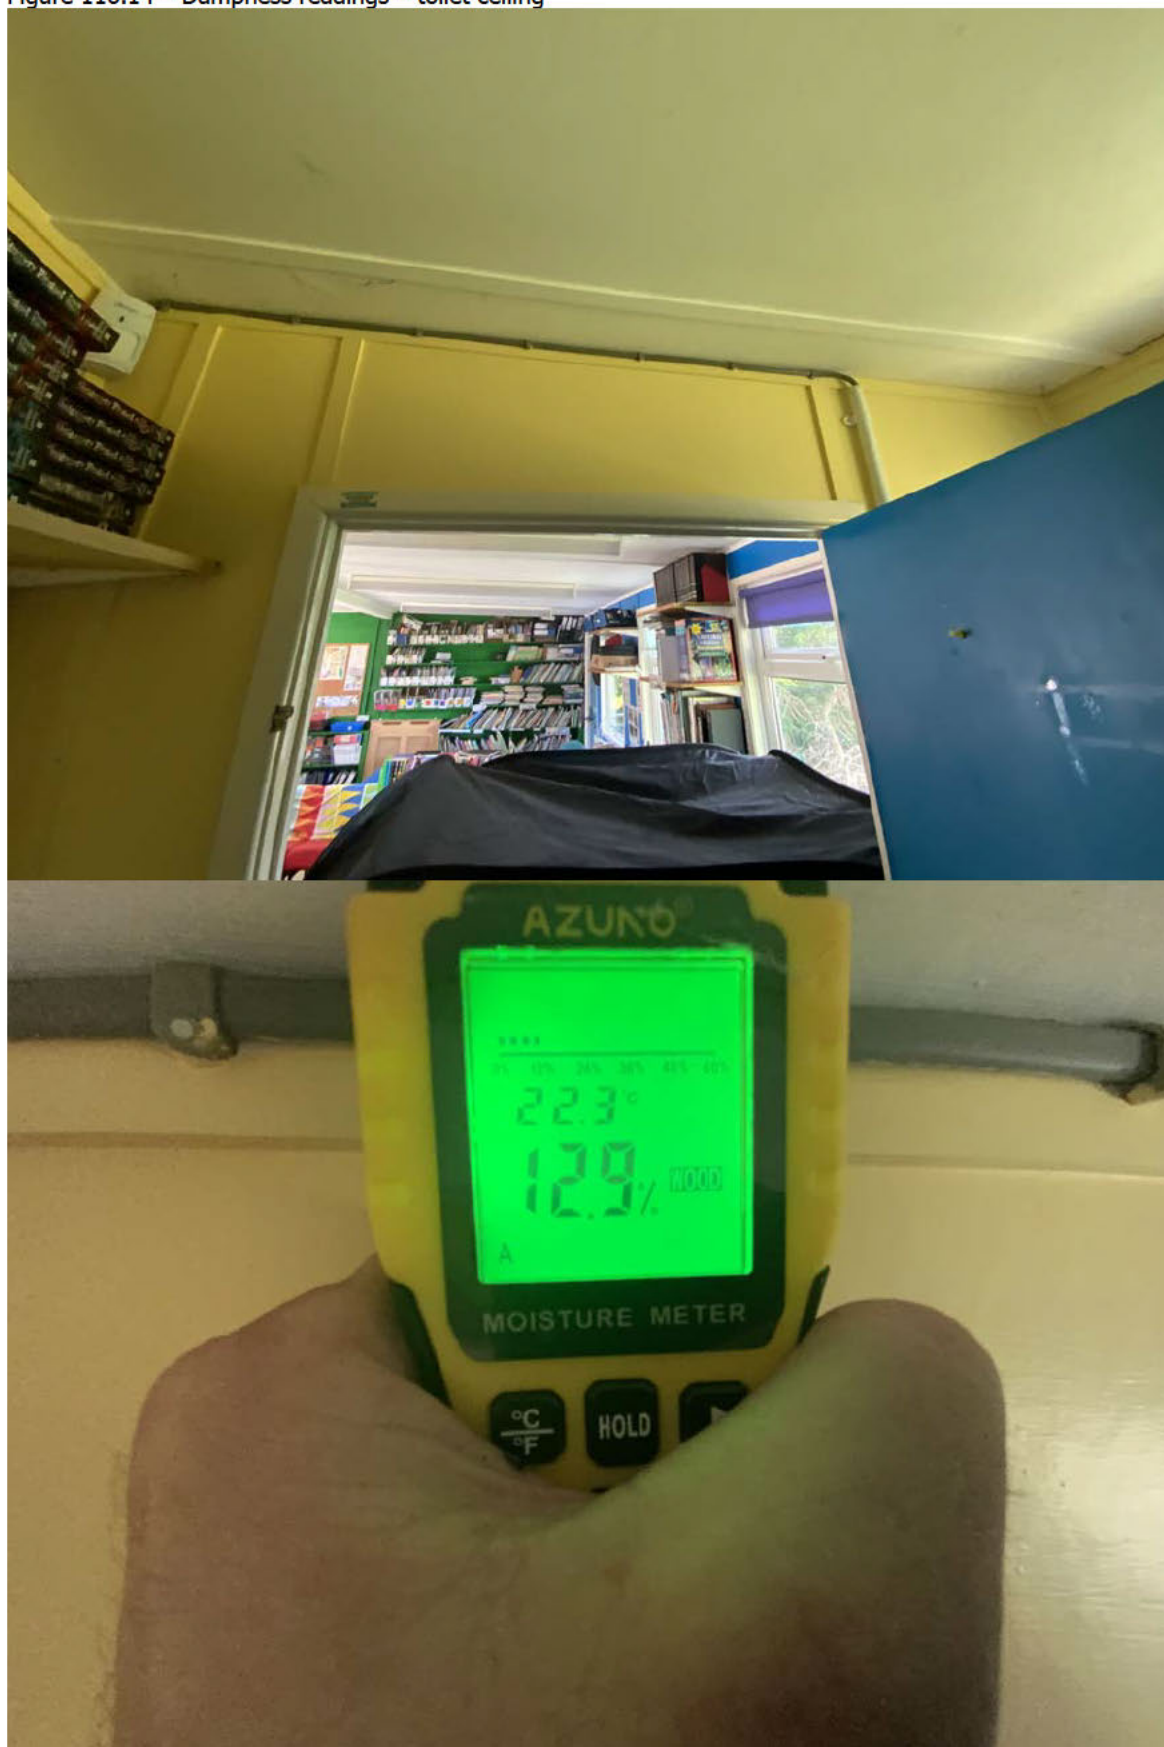
Figure 116.14 – Dampness readings – toilet ceiling

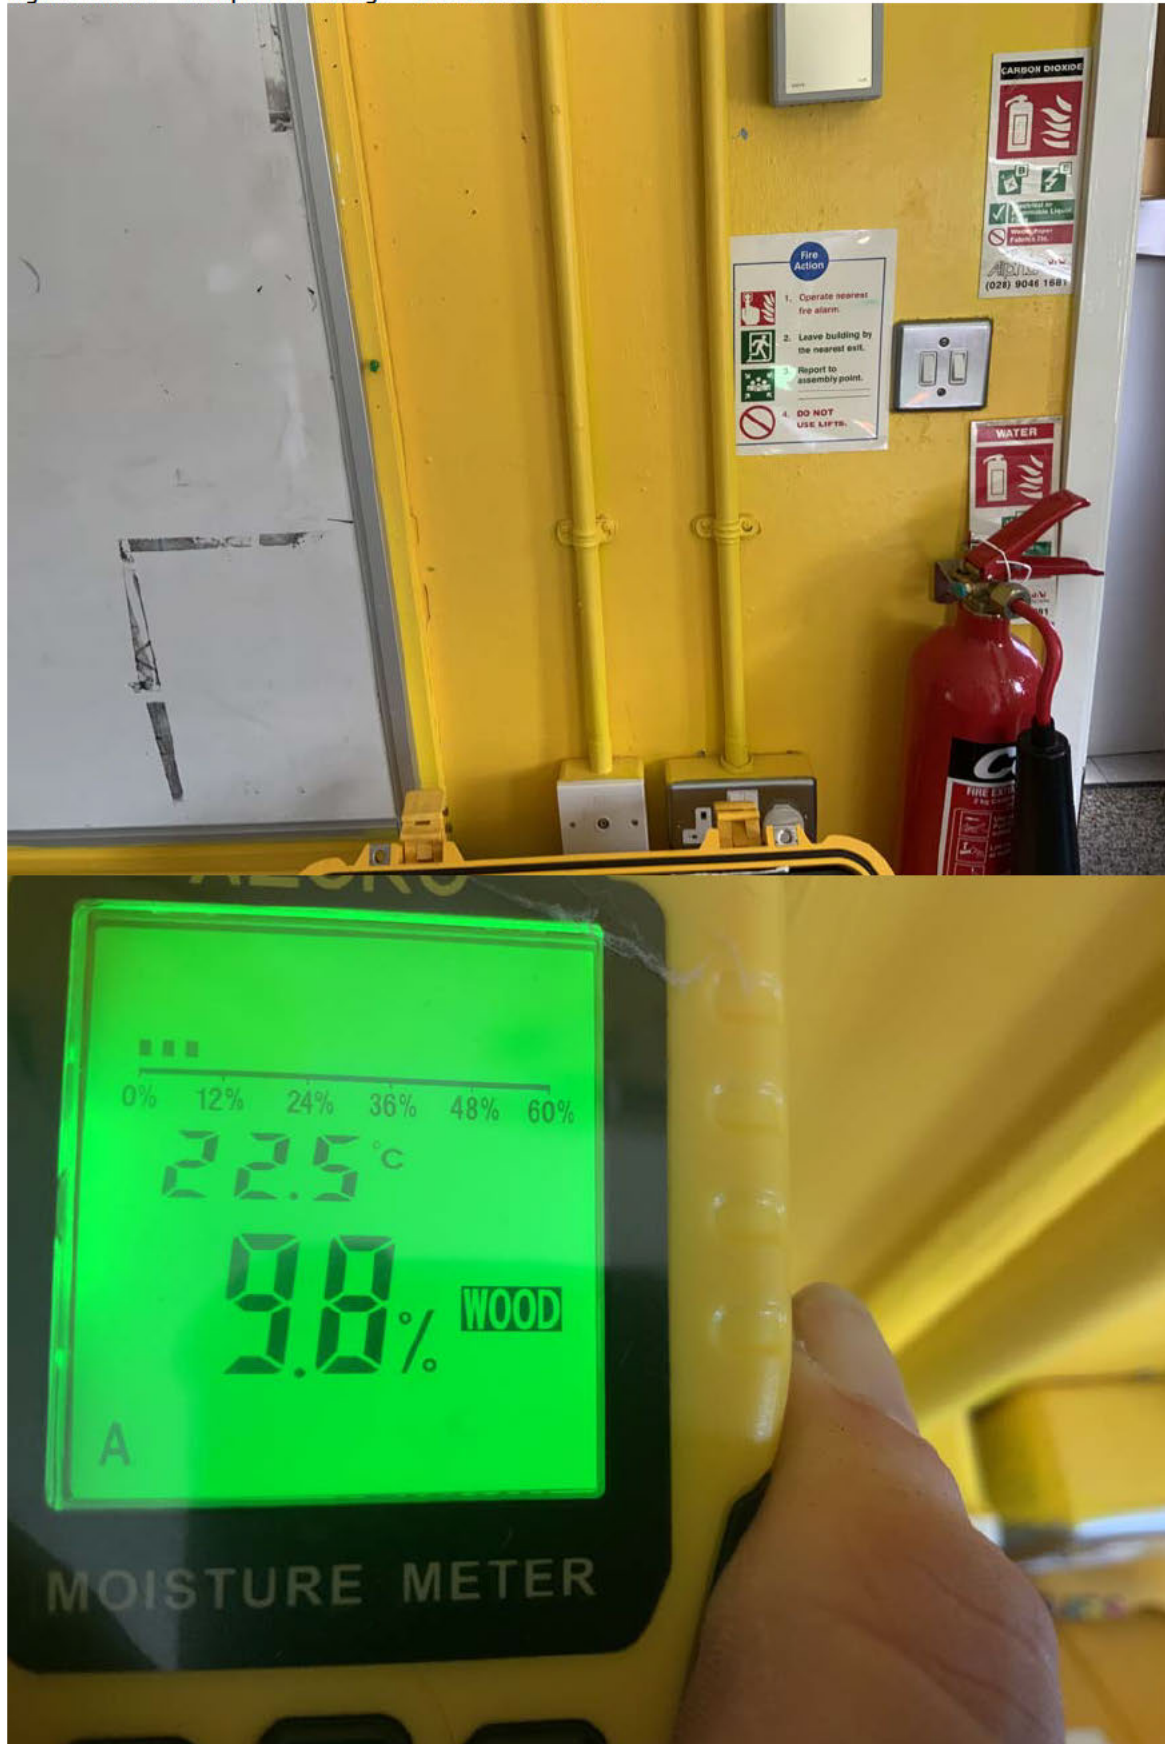
Figure 116.15 – Dampness readings – internal stud wall

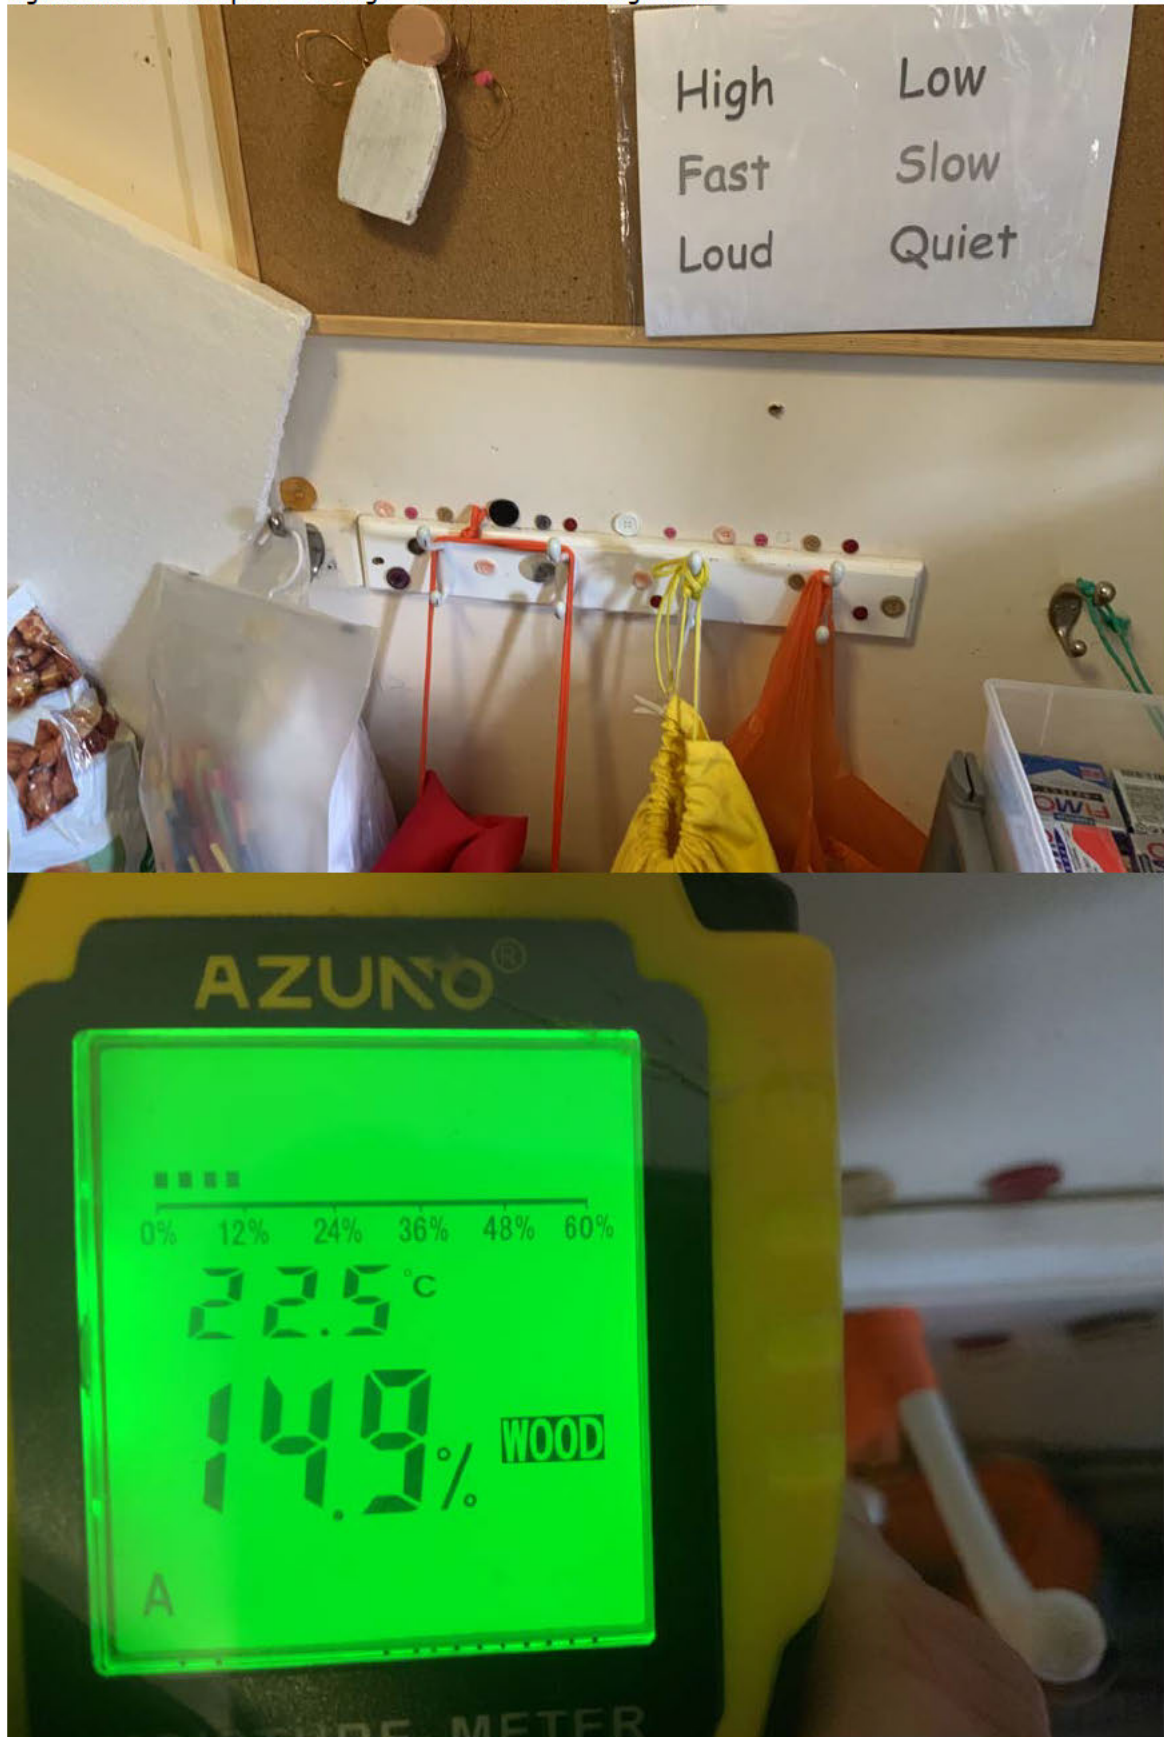
Figure 116.16 – Dampness readings – northeast wall storage area

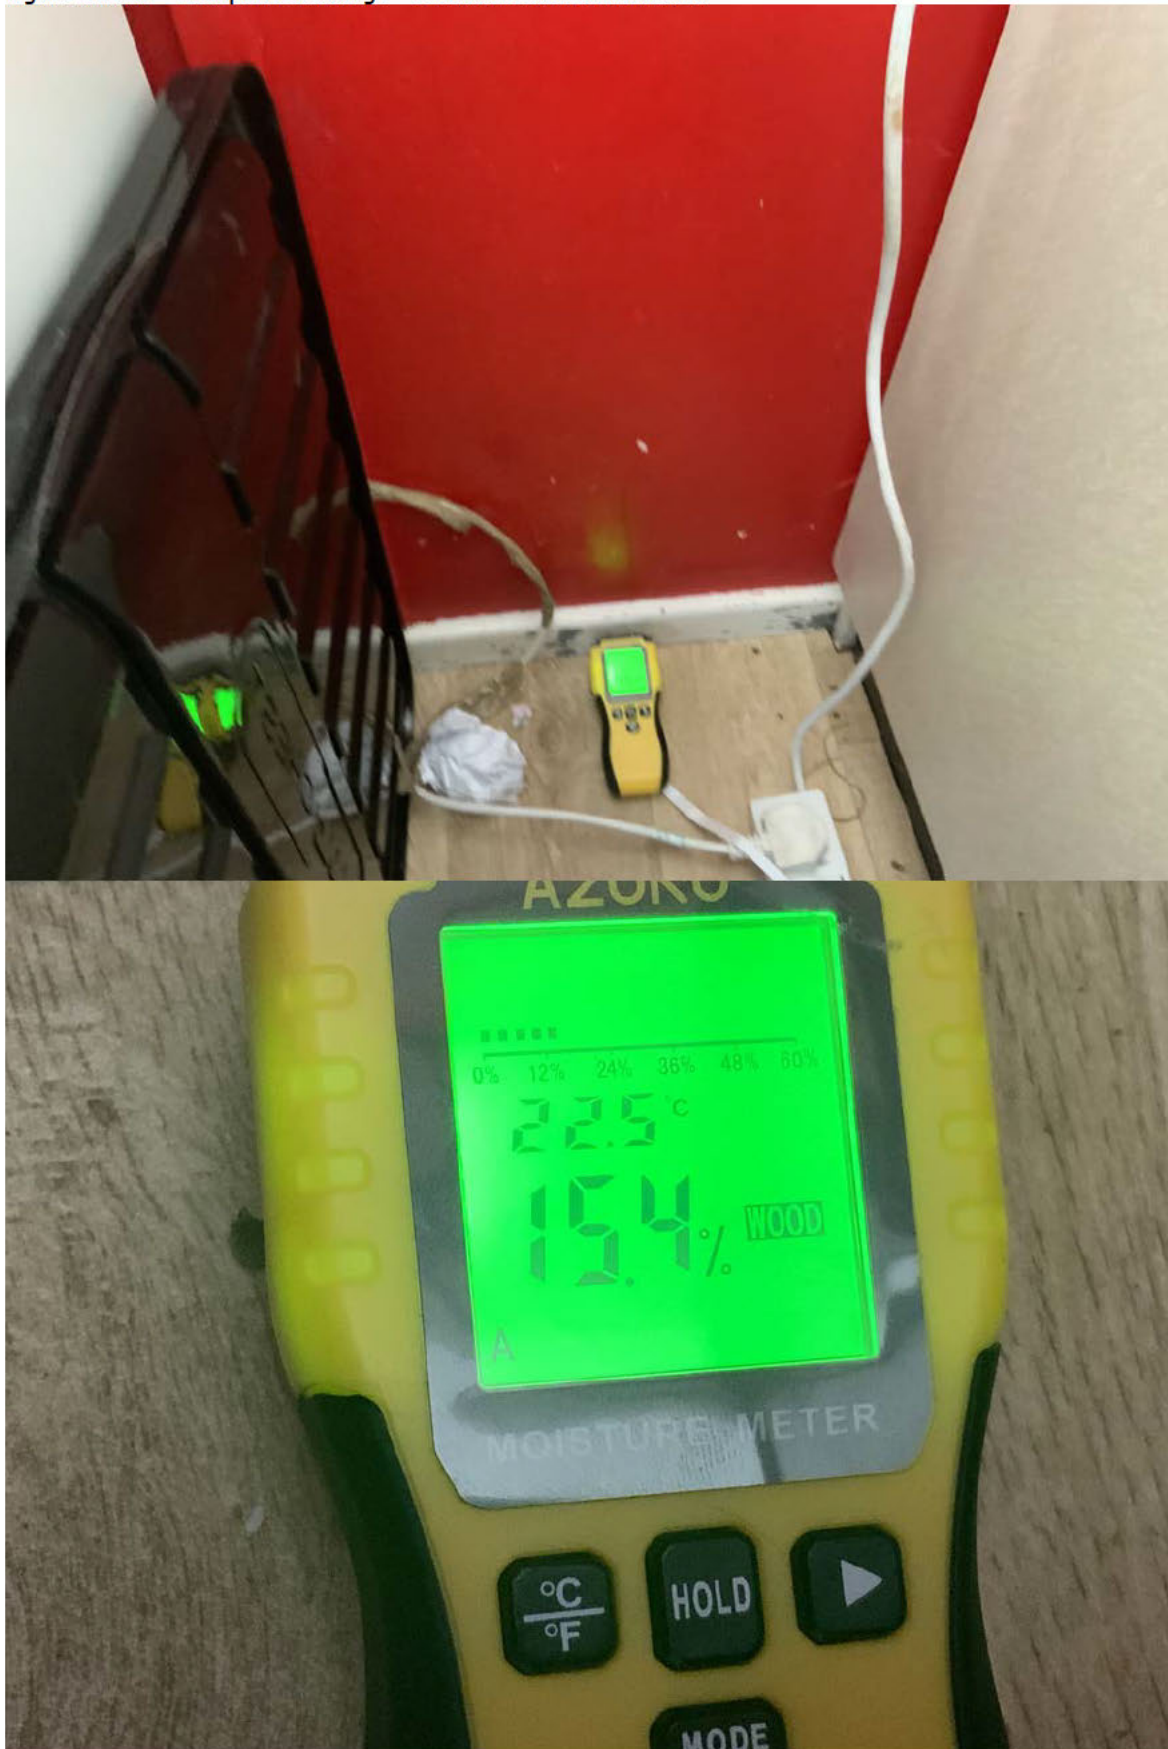
Figure 116.17 – Dampness readings – southwest wall kitchen area

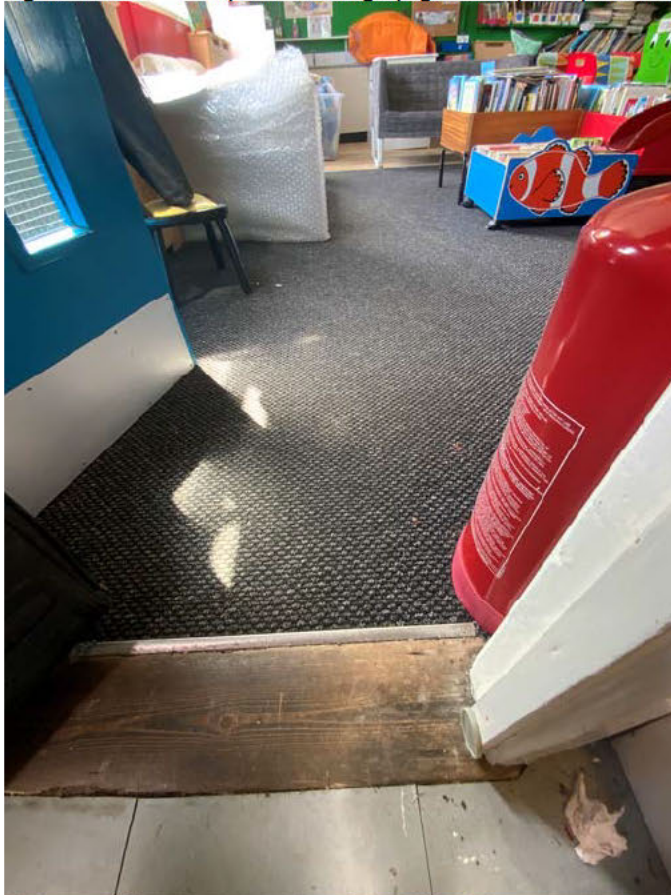
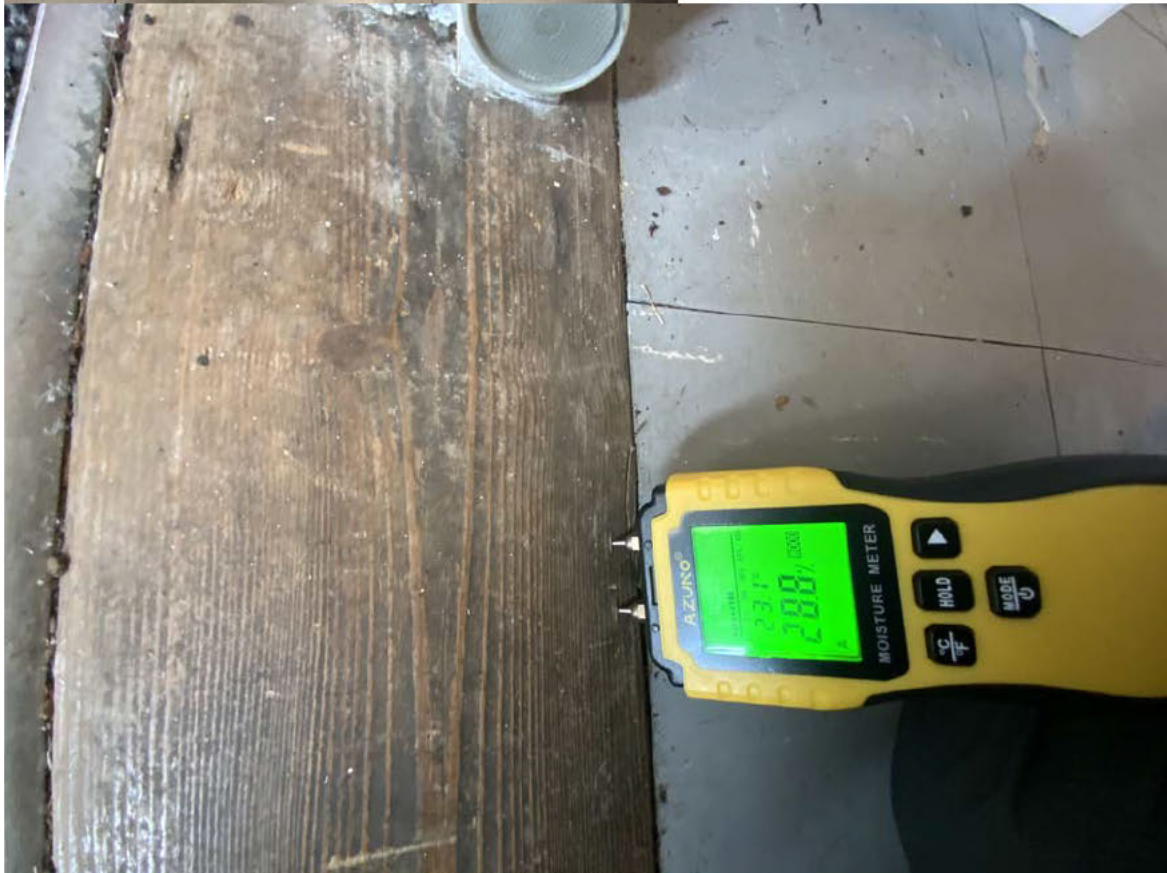
Figure 116.18 – Dampness readings (significantly damp area shown here in door saddles)

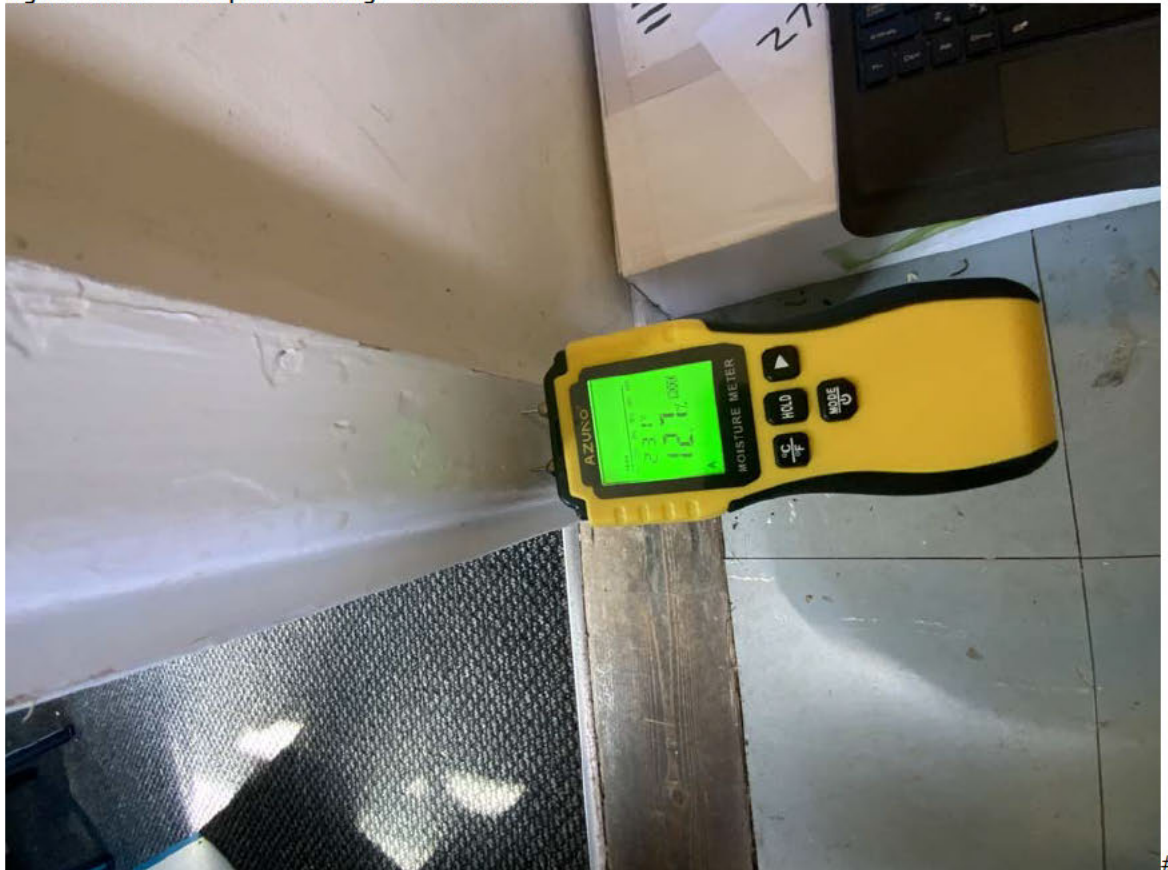
Figure 116.19 – Dampness readings – door frame

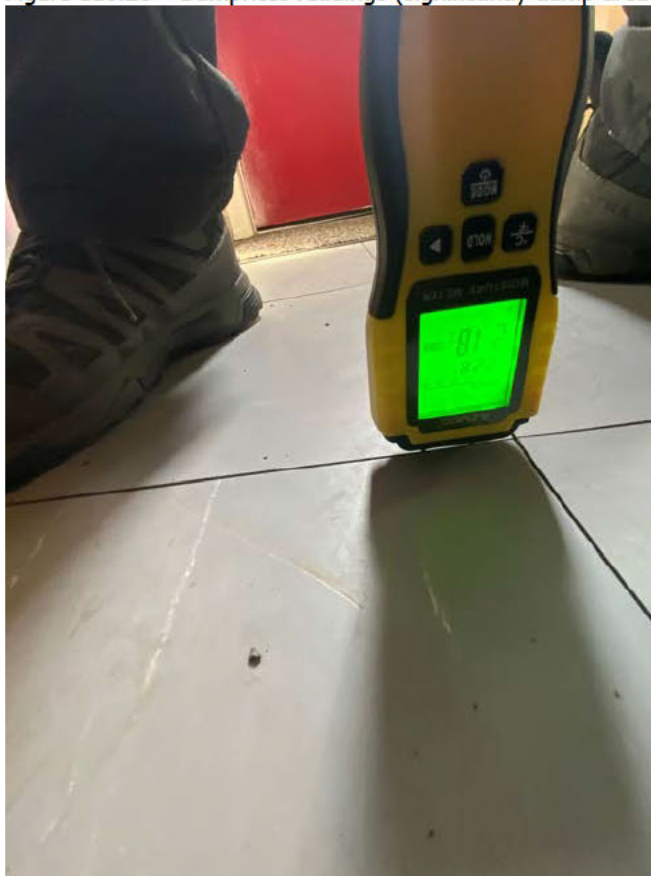
Figure 116.20 – Dampness readings (significantly damp area shown here for floor of main entrance)

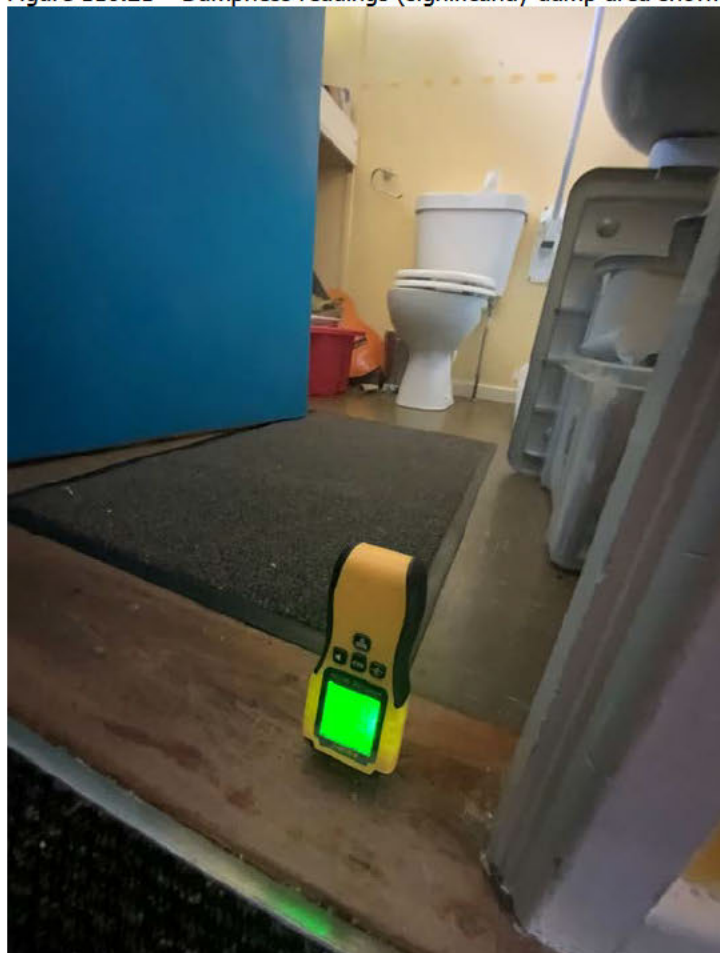
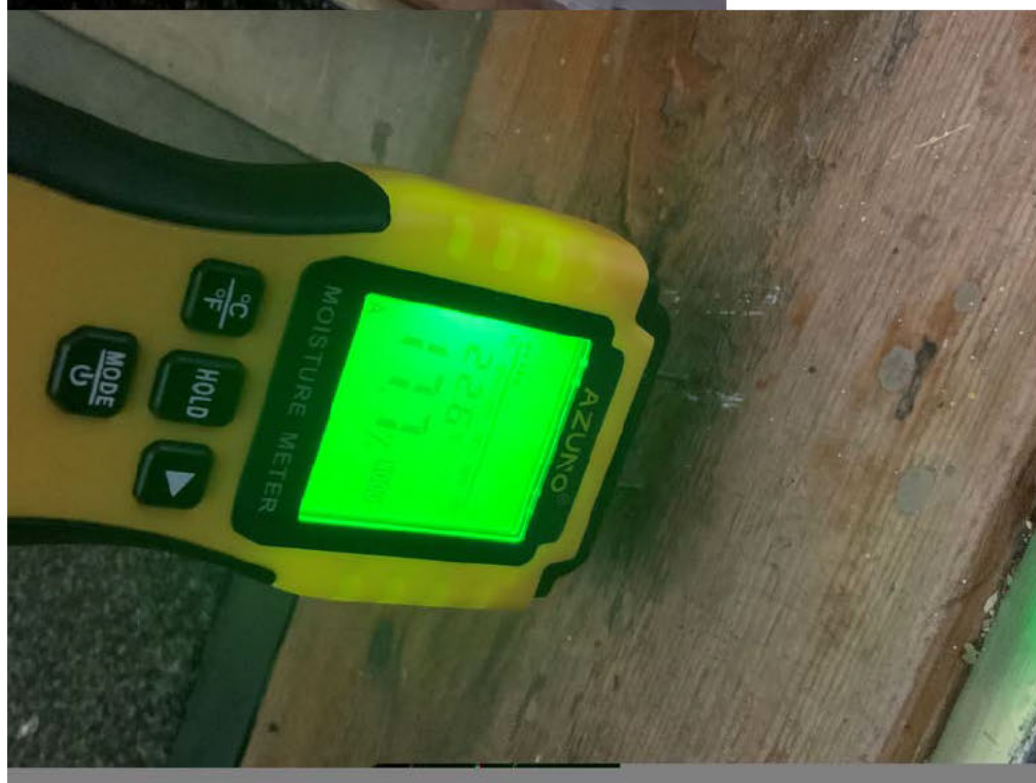
Figure 116.21 – Dampness readings (significantly damp area shown here for door saddles)

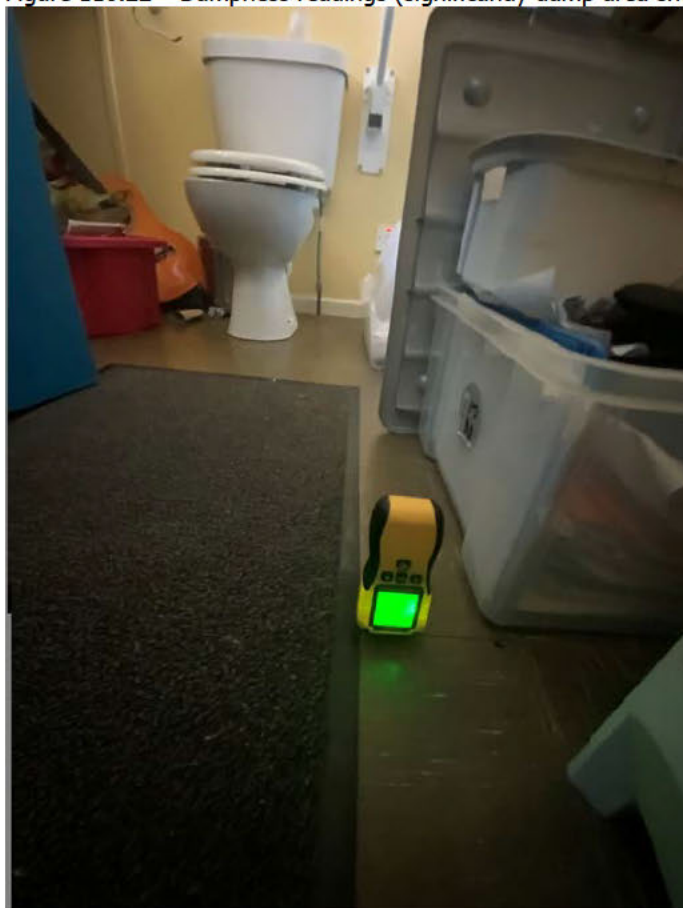
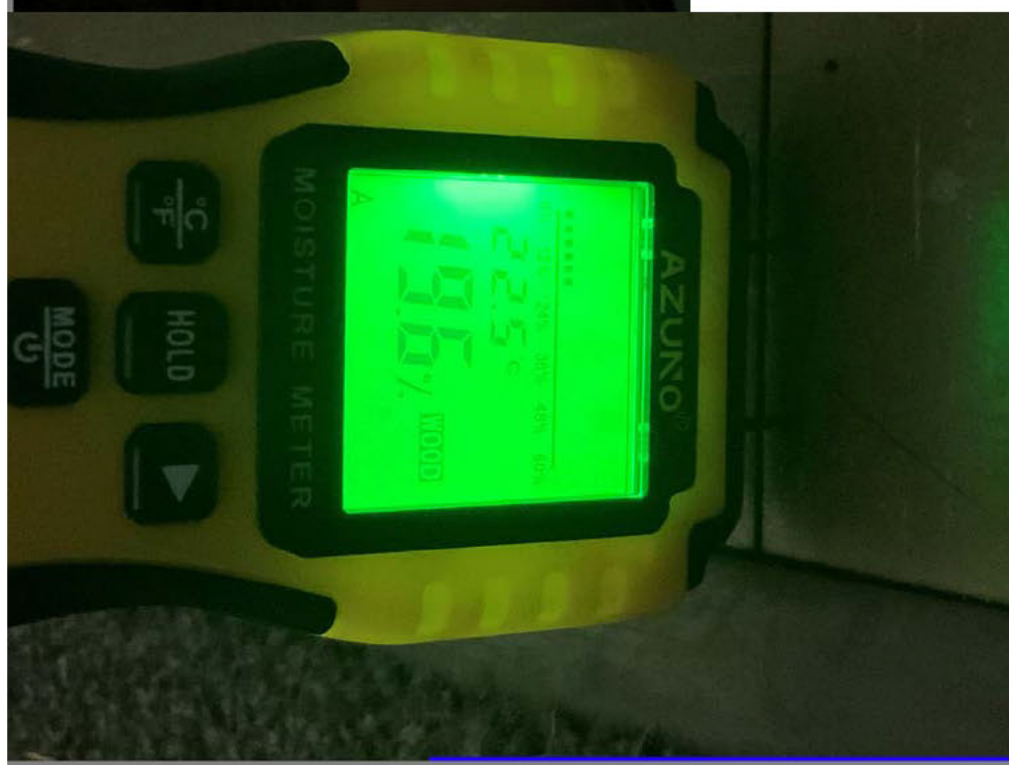
Figure 116.22 – Dampness readings (significantly damp area shown here for floor of toilet)

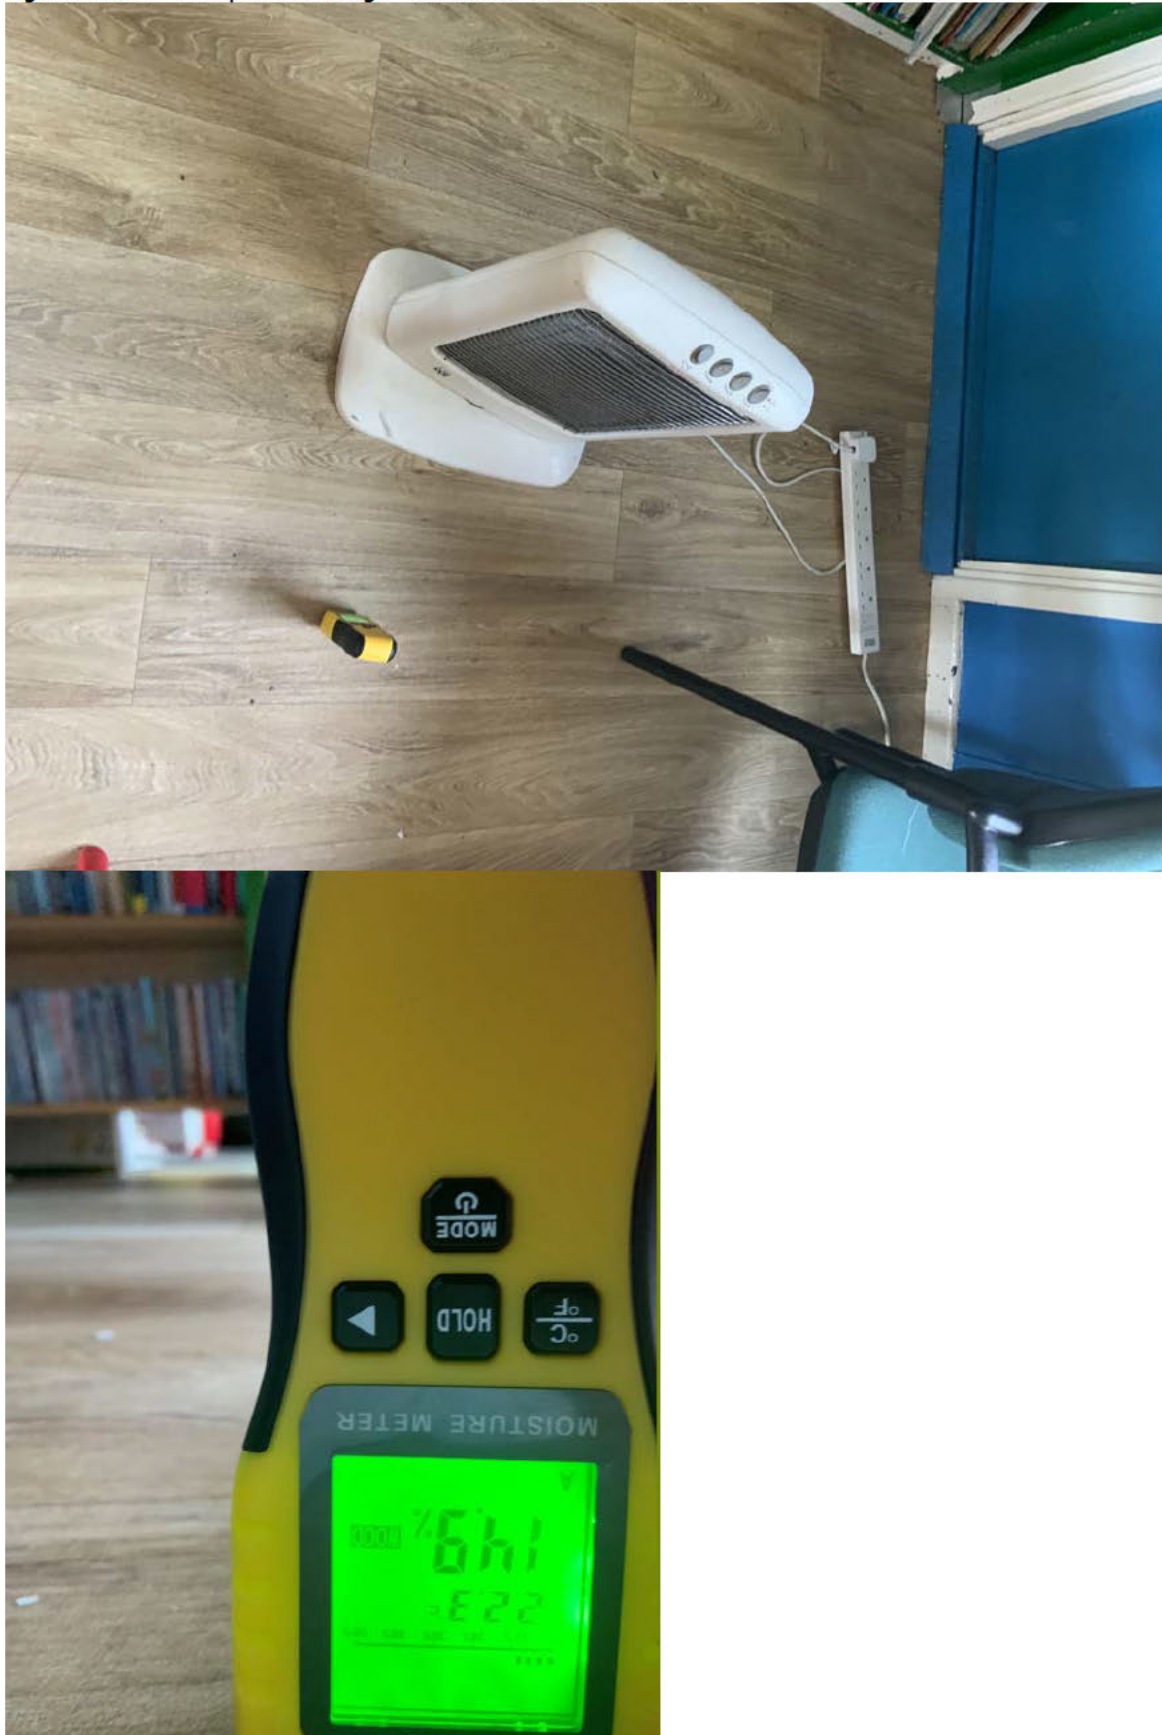
Figure 116.23 – Dampness readings – floor area with movement

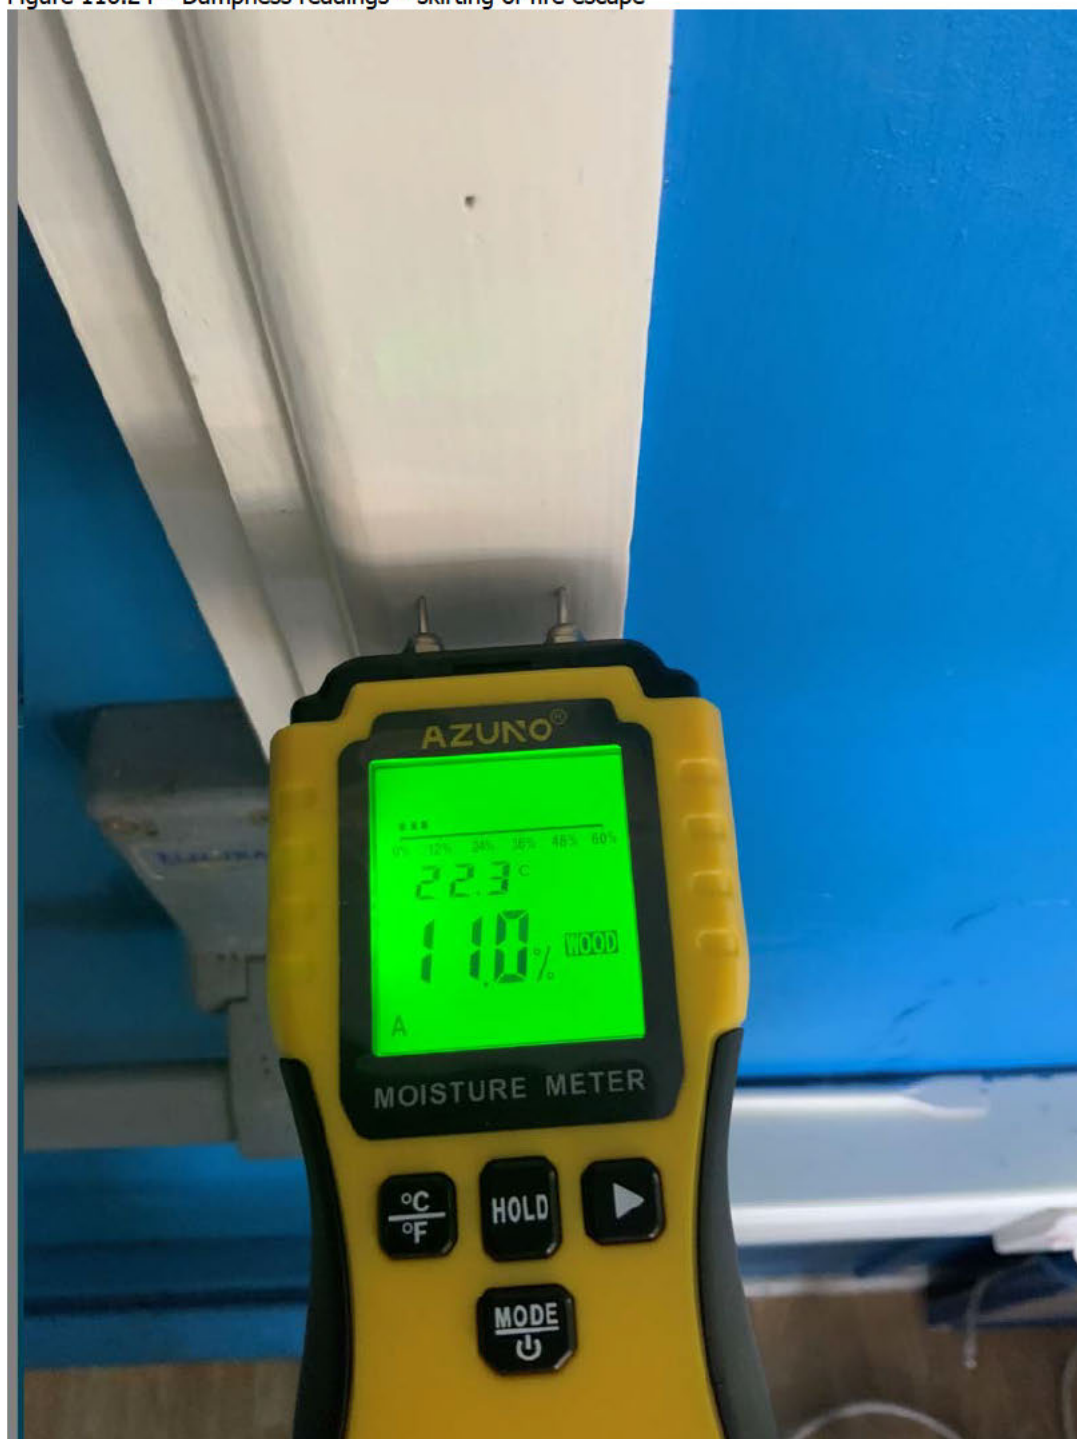
Figure 116.24 – Dampness readings – skirting of fire escape

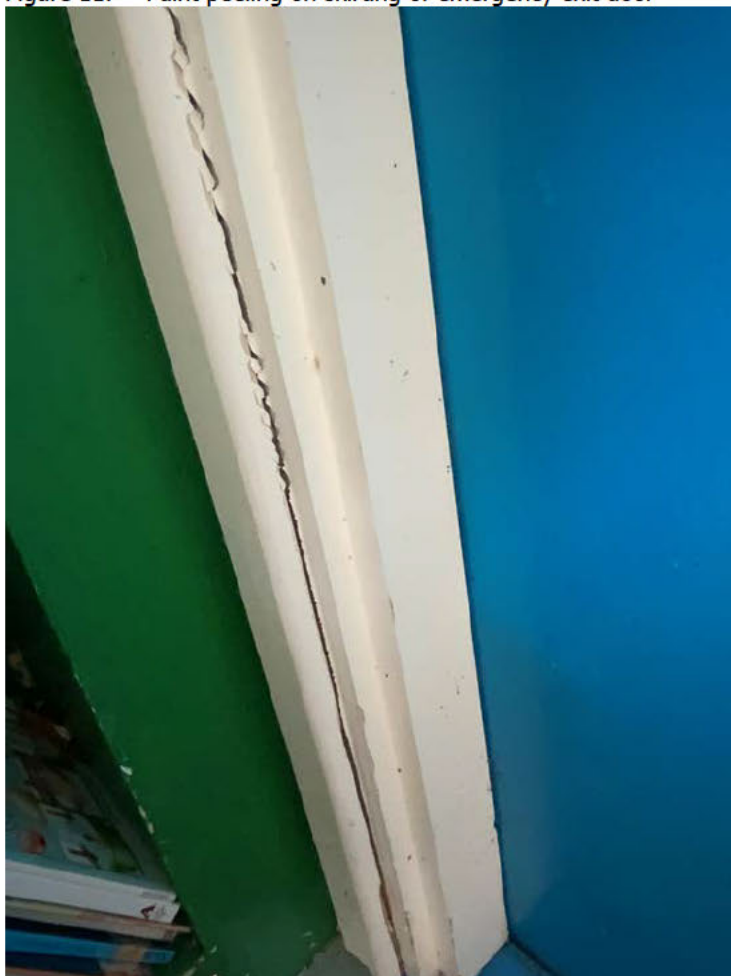
The timber skirtings and architraves are in satisfactory order although there is likely internal damage due to damp conditions (refer to 14.00). Paint on skirting on emergency exit door peeling and exposing wood (see figure 117).

Figure 117 – Paint peeling on skirting of emergency exit door

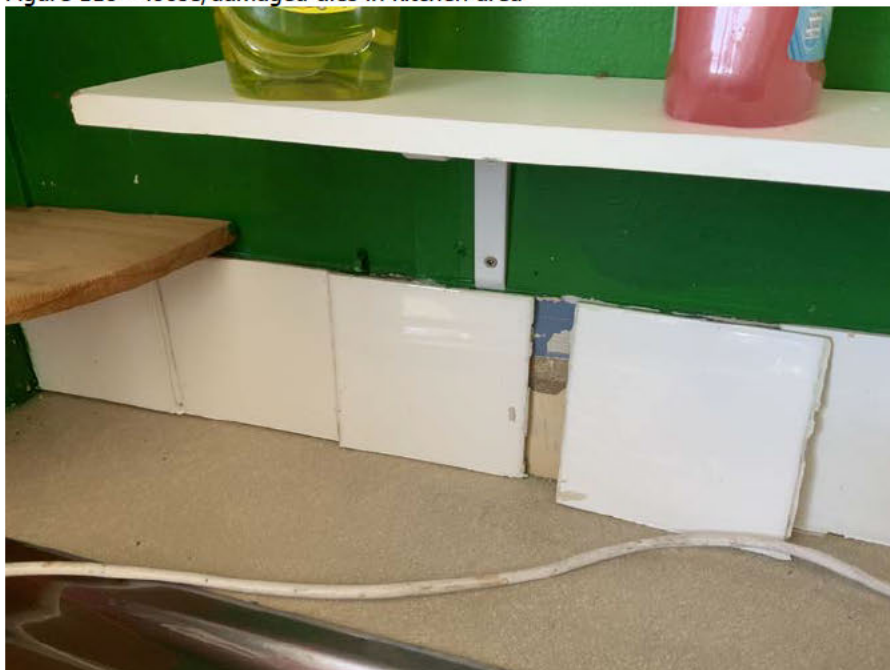
16.01 These are in fair condition although there are a few minor blemishes and areas that require touching-in. A section of tiles in the kitchen area would benefit from being reinstalled (see figure 118).

Figure 118 – loose/damaged tiles in kitchen area

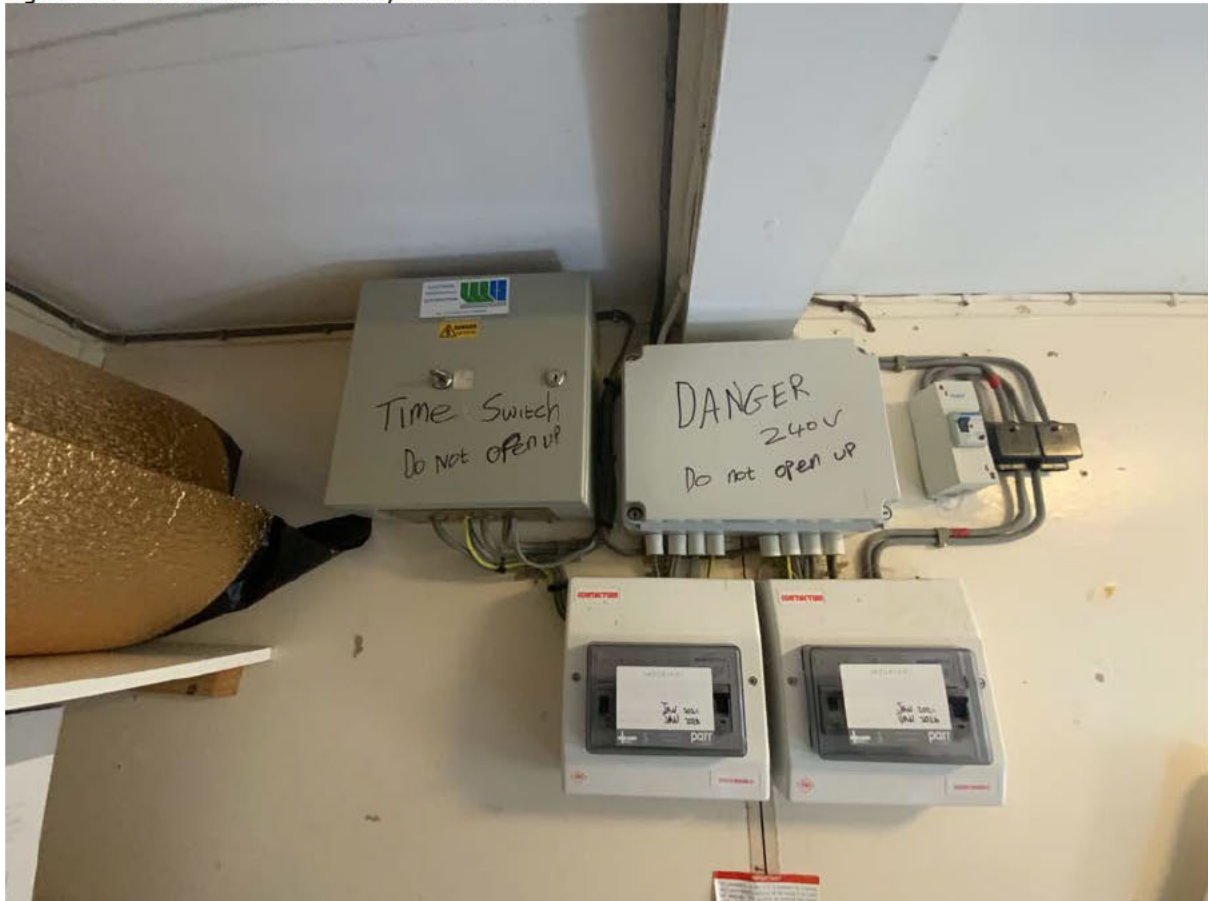
Figure 119 – wall mounted electricity switch boards
