**PRIVATE & CONFIDENTIAL  
BUILDING SURVEY REPORT  
PROPERTY STRANGFORD AREA  
St Joseph's Primary School  
Date of Inspection May 2023  
Weather: Clear  
Ref: 20230524**

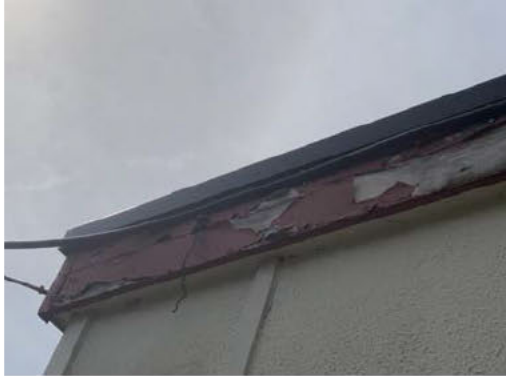
Figure 103.01 (northeast elevation)

Figure 103 – Peeling paint on external walls

1.18 Redecorate peeled paintwork on external walls. (figure 103)

10.01 The external decorative condition is inadequate. Paint is peeling in a number of places and redecoration should be carried out (see figure 103). Any decoration that is undertaken should match in with the rest of the grounds.
